# PRESERVATION OF A LARGE CHINESE BANYAN ON A CONSTRUCTION SITE

by C.Y. Jim

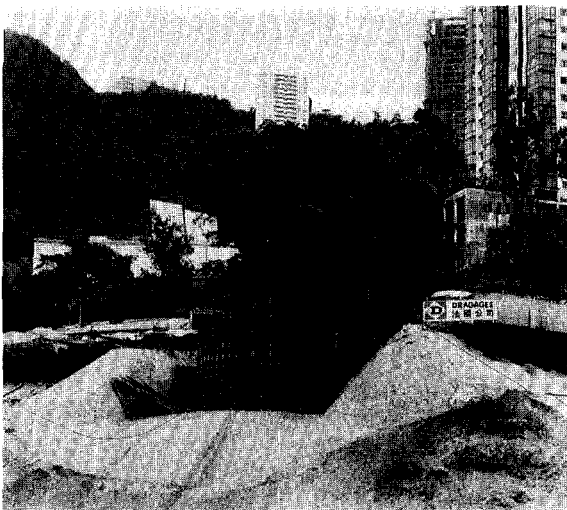
The tree of interest was planted on a platform between two three-story army barracks which had since been demolished. It is a sizeable specimen with a 2m dbh, 15m height, 22m crown spread, and an estimated age of 60 years (Fig. 1). It is reasonable to expect the tree to live for at least 100 more years and attain a bigger final size. Despite a lack of arboricultural care, it has only a few broken and dead branches, and is generally

Figure 1. The Chinese Banyan (*Ficus microcarpa*) perching on the colluvial slope that has been cut back. Its roots are contained in the soil mass surrounded by sheet-piles which form the vertical wall of the huge concrete planter at 10m deep and 18m diameter.

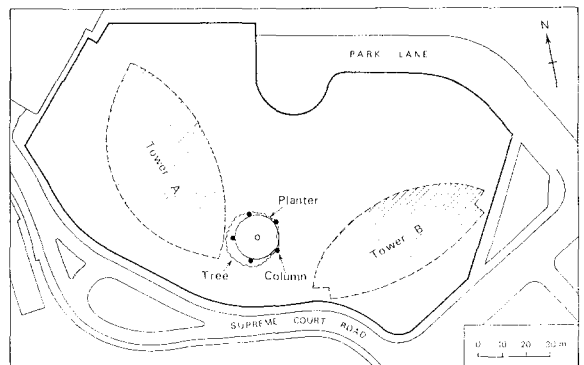
Figure 2. Location of the Chinese Banyan tree in relation to the two tower blocks to be erected on the site. Note the size of the planter in relation to the crown, and that of the crown in relation to the narrow gap between the two towers.

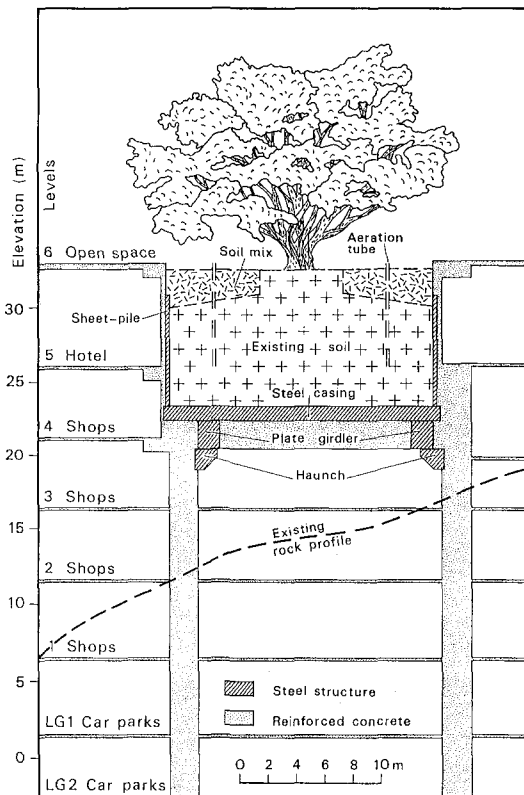
**Engineering measures.** The retention of the tree was complicated by the developer's intention to build five stories (shops and carparks) below the tree (Fig. 3). In essence, a huge concrete planter 10m deep and 18m diameter was constructed to contain the rooting soil mass and was thus detached from the surroundings. Engineering procedures were started after root pruning and other arboricultural attentions (see next section). Initially, contiguous sheet-piles were inserted vertically around the 18m-diameter perimeter as temporary support (Fig. 1). The piles were driven in short sections to avoid damaging the crown. Five caissons were then excavated outside the piles, and reinforced-concrete columns were cast inside

**Figure 3.** Engineering measures adopted to create a huge concrete planter. The steel structures provide temporary supports whereas the reinforced concrete provide the permanent casing for the planter. Construction proceeds top-down from the bottom of the planter (Source: adapted from diagram supplied by contractor).

The soils around the sheet-piles were removed to allow contiguous hollow steel casings to be driven horizontally into the bottom of the enclosed soil mass. The soils inside the casings were bored out and prefabricated steel beams inserted. The spaces between the casing and beam were grouted with concrete. Excavation under and around the new floor-slabs provided room to install steel plate girders and haunch brackets which were linked to the supporting columns (Fig. 3). Finally, reinforced concrete beams were cast below the floor-slabs and walls encircling the sheet-piles to give a permanent shell to the planter. Drainage pipes and outlets were installed at the bottom. Thereafter, the top-down construction of basement floors could proceed while the tree was protected by sufficient hoardings against

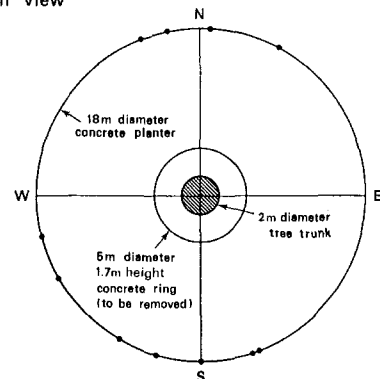
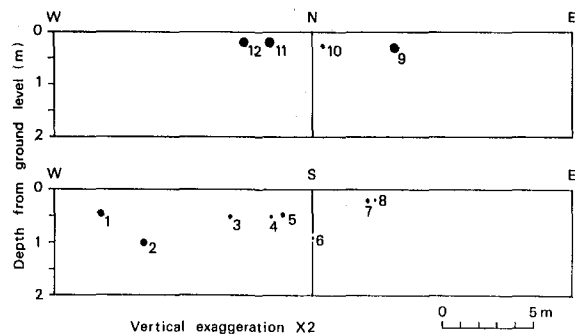
*Arboricultural considerations.* In preparation for root containment, dead, broken, and diseased wood was removed from the tree and cable bracing was installed to support the trunk and main branches. In addition, an irrigation basin was made and gravel-filled aeration tubes and an irrigation system were installed. Roots were pruned at approximately the drip-line in two stages to minimize shock. The initial trench, 0.75m wide by 1.5m deep, was followed after two months by a larger trench of 1.5m wide by 2.5m deep. To stimulate fibrous-root growth (3) trenches were immediately refilled with coarse materials. Root distribution and size above 10mm diameter in the trenches were recorded at the time of trenching and are plotted in Fig. 4. All roots greater than 10 mm were found in the top 1m of soil, indicating that the planter was adequate for the tree at present. The large

**Figure 4.** Distribution of roots over 10mm diameter on the walls of the root-pruning trenches. Note the concentration of roots in the top 1m of the soil, and the paucity of roots at the 18m perimeter (Source: adapted from diagrams supplied by contractor).

rooting volume ensures a sufficient reservoir for the storage of available moisture, reduces the shock of root pruning, and allows future expansion of the root system. The removal of the concrete collar and pavings around the tree and the raising of soil to its original level (Fig. 3 and 4) may be detrimental to the roots. The use of coarse soil fills and the installation of vertical, gravel-filled, aeration tubes are necessary to maintain air exchange in the buried soil.
