PRESERVATION OF A LARGE CHINESE BANYAN ON A CONSTRUCTION SITE

by C.Y. Jim

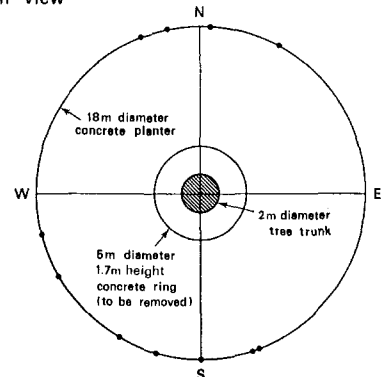
Arboricultural considerations. In preparation for root containment, dead, broken, and diseased wood was removed from the tree and cable bracing was installed to support the trunk and main branches. In addition, an irrigation basin was made and gravel-filled aeration tubes and an irrigation system were installed. Roots were pruned at approximately the drip-line in two stages to minimize shock. The initial trench, 0.75m wide by 1.5m deep, was followed after two months by a larger trench of 1.5m wide by 2.5m deep. To stimulate fibrous-root growth (3) trenches were immediately refilled with coarse materials. Root distribution and size above 10mm diameter in the trenches were recorded at the time of trenching and are plotted in Fig. 4. All roots greater than 10 mm were found in the top 1m of soil, indicating that the planter was adequate for the tree at present. The large

Figure 4. Distribution of roots over 10mm diameter on the walls of the root-pruning trenches. Note the concentration of roots in the top 1m of the soil, and the paucity of roots at the 18m perimeter (Source: adapted from diagrams supplied by contractor).
