TREE ROOTS IN SEWER SYSTEMS IN MALMO, SWEDEN

by Kaj Rolf and Örjan Stål

Abstract. Three sites with root intrusion problems in the City of Malmö were inspected to find different solutions to the problems. All sites had high maintenance costs due to the roots. Alternative measures for each site were selected. Each site was treated differently depending on the technical, aesthetic, cultural and economical values. At one site, pipes were relined, at another the trees were replaced with less aggressive species and at the third a decision is yet to be made.

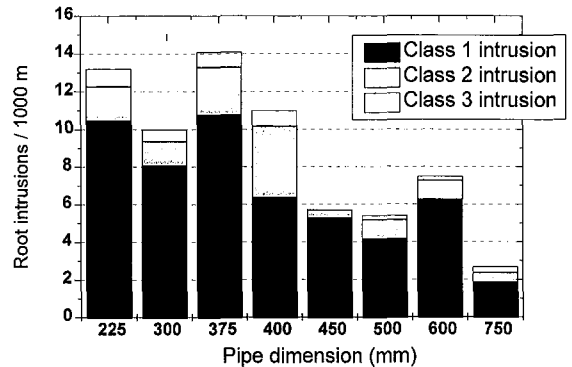
Root intrusion in sewer pipes has been well studied in the city of Malmö (1,2). The study is based on video recordings inside the pipes and provides data on root intrusions per 1000 m. Data are separated depending on age and dimension of the pipe. The most intrusions have been onto the smaller dimension pipes, 22.5 - 40 cm (Figure 1)(3), possibly because the larger dimensions are more often used as primary sewer lines or trunk sewers. These larger pipes are usually deeper in the soil and the roots may have problems growing down to them.

Figure 1. Root intrusion / 1000 m sewer pipe in the City of Malmö. Figures are divided into pipe dimensions.

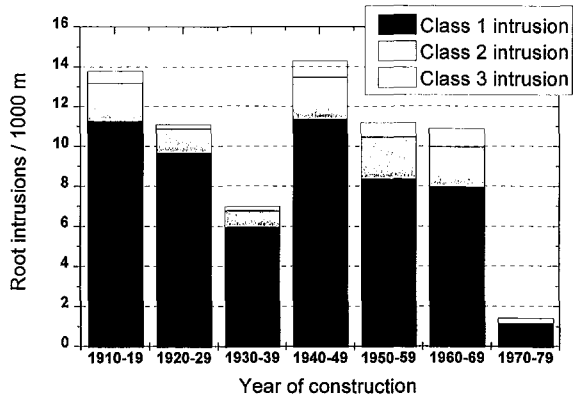
Data show that pipes laid down in the nineteen-fifties and earlier, with the exception of the nineteen-thirties, have the largest number of root intrusions (Figure 2)(1). During these years the sealing material was made of yarn and cement. During the war the quality of the material was poorer because of rationing. Why there were so few root intrusions in pipes from the nineteen-thirties is hard to explain. One reason may be that areas constructed during this period have not had so much vegetation near the pipes. During the nineteen-fifties the less effective plastic seals were introduced and from the nineteen-sixties to

Figure 2. Root intrusion / 1000 m sewer pipe in the City of Malmö. Figures are divided into year of construction.

now rubber seals have been used. The large number of root intrusions in pipes from the sixties may be explained by the boom in the construction industry. Construction work had to be fast and cheap, which created negligence during the work. There is also a hypothesis that the number of root intrusions in these pipes will increase when the trees get larger.

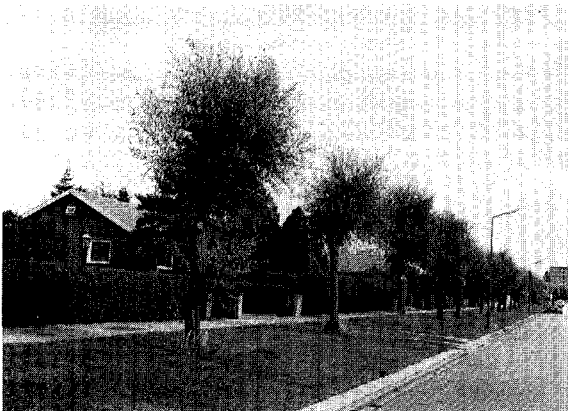
intrusion in sewer and drain systems. The trees were growing in a grassed area between the street and the private gardens (Figure 5). The trees were growing close to the sewer pipes and in some cases even immediately above the pipe.

The sewer system was built in 1948-1956. The pipes are made of concrete and the joints were sealed with yarn and cement. This means that tree roots easily can penetrate the joints. The maintenance costs were calculated to SEK 186 (\$ 23.50) / meter each year. To that sum should be added the amount the residents had to pay for cleaning their own service connections.

The soil. There were no actual planting pits for the trees. There was a 25 - 30 cm thick top soil layer and below the top soil there was a heavily compacted clay subsoil. The roots grew horizontally along the compacted subsoil surface and down in the less compacted pipe trench.

Figure 5. The street Vanåsgatan was built in the late nineteen-forties with a combined sewer system made of concrete. The trees were growing in a grassed area between the street and the private gardens.

Alternative 2, relining. This alternative guarantees that the pipes will be free from root intrusion, but the construction required heavy expenses, SEK 1575 (\$ 200) / meter of line. There would also be an expense for the private house-owners since the relining must be done all the way to the house. Otherwise, there is a risk that roots will penetrate the joint between the old and new systems. After 7.5 years, the expense would have paid for itself since the routine maintenance costs will have been eliminated. The advantage of this alternative is that you retain the character of the street with the willow trees.

Alternative 3, changed design. A new design with new trees would cost SEK 850 (\$ 105) / m². This means that the costs will be paid after 6 years compared with the present maintenance program.

Decision, use alternative 3. This meant that all willows were taken down and new trees were planted. The species chosen were maple, *Acer platanoides* 'Schwedleri' where there was enough space and *Cercidiphyllum japonicum* and *Prunus sargentii* in groups according to Figure 8, which shows the street one year after replanting.

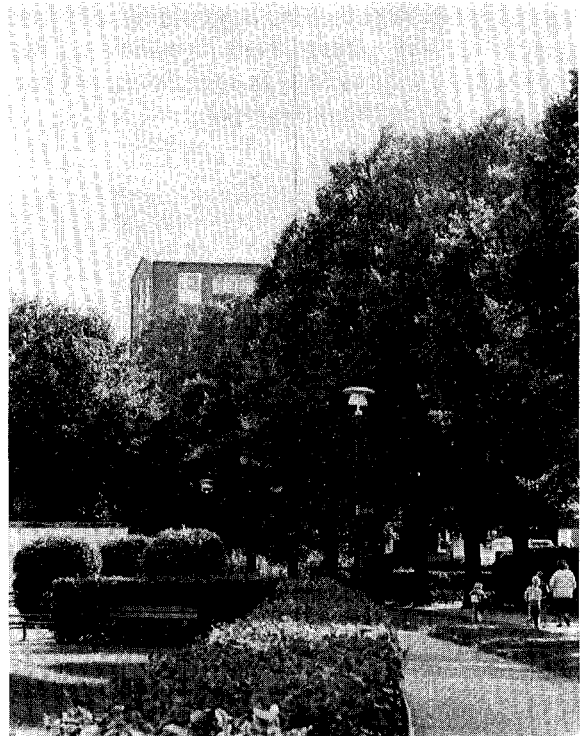
II. Rödkullastigen from number 3 to 9. Rödkullastigen is a housing area with high-rise buildings and large green open spaces with bicycle paths. Along one bicycle path, several smooth-leaved elms are growing (Figure 6). The main sewer pipe is located in this road. There are no immediate problems with root intrusion, mainly due to the big size of the sewer line. Service connections were located 1-2 meters from the trees and the sewer line was located 3-4 meters from the trees.

Trees: smooth-leaved elm, *Ulmus carpinifolia* 'Hoersholmii'. All elm trees were between 30 and 40 years old. Elms are relatively fast-growing and can be fairly old. The root system is wide and rather extensive but much less aggressive than willows and poplars. Old elm trees have a large root system that may cause problems with root intrusion.

The sewer system was built in 1958. Both the sewer line and the service connection are made of concrete. The pipe dimension was 22.5 cm in diameter and the joints were sealed with yarn and cement. Tree roots could easily penetrate the joints. The maintenance costs were calculated to SEK 97 (\$ 12) / meter each year.

Figure 6. Rödkullastigen is a housing area with high-rise buildings and large green open spaces with bicycle roads. Several smooth-leaved elms are growing along one of the bicycle paths.

Alternative 2, pipe cracking (a). This alternative requires rehabilitation of the old pipes and or alternative (b), relining. This alternative guarantees that the pipes will be free from root intrusion and will cost SEK 1369 (\$ 170) / meter.

Decision, use alternative 2b.

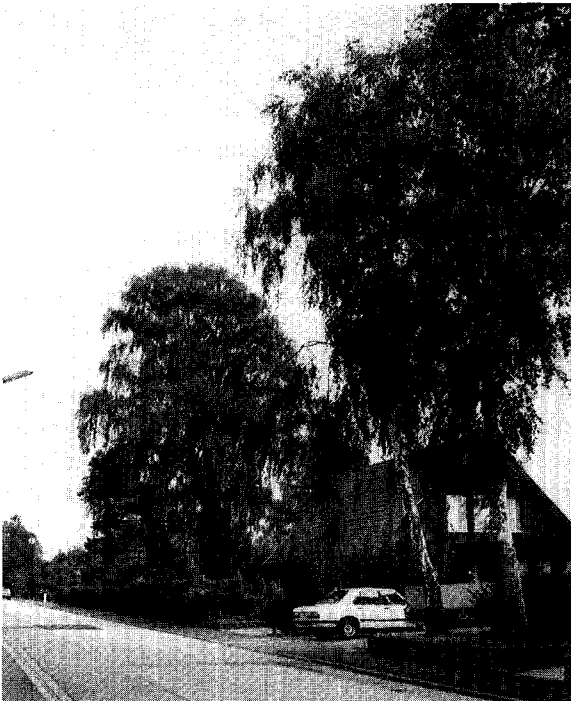
Kungshällagatan is a street in a residential area built between 1954 and 1956. The sewer line is a combined sewer located in the middle of the street. Unlike the other two areas, the problems in this area are caused by trees growing on private property (Figure 7). The part of the street that had the most severe root intrusion is a section about 80 m long. Along this section there are some large birches in the private gardens. This means that the service connections were 2-4 meters and the sewer line was 4 meters from the trees.

Trees: common birch, *Betula pendula*. In the private gardens there were several different species but at the places where root intrusion occurred, common silver birches aged 30-35 years old were growing. The root system is rather intensive and often stays close to the stem but in less favorable soil conditions the root system can be wide-spread.

The sewer line was 22.5 cm in diameter and the service connection 15 cm in diameter. The pipes are made of concrete and the joints were sealed

Figure 7. Kungshällagatan is a street built between 1954 and 1956. The sewer line is a combined sewer located in the middle of the street. The problems in this area were caused by trees growing on private property.

with yarn and cement. Tree roots can easily penetrate the joints. The maintenance costs were calculated to SEK 90 (\$ 11) / meter each year.

The soil. Since the trees were on private property, no actual soil examination was made. The trees were very close to the street and tree roots must have followed the pipe trench out into the street.

Alternative 2. Inform the homeowners of the present situation and how it may develop in the near future. Present the different alternative measures and try to convince the homeowners

Decision, none at this time.

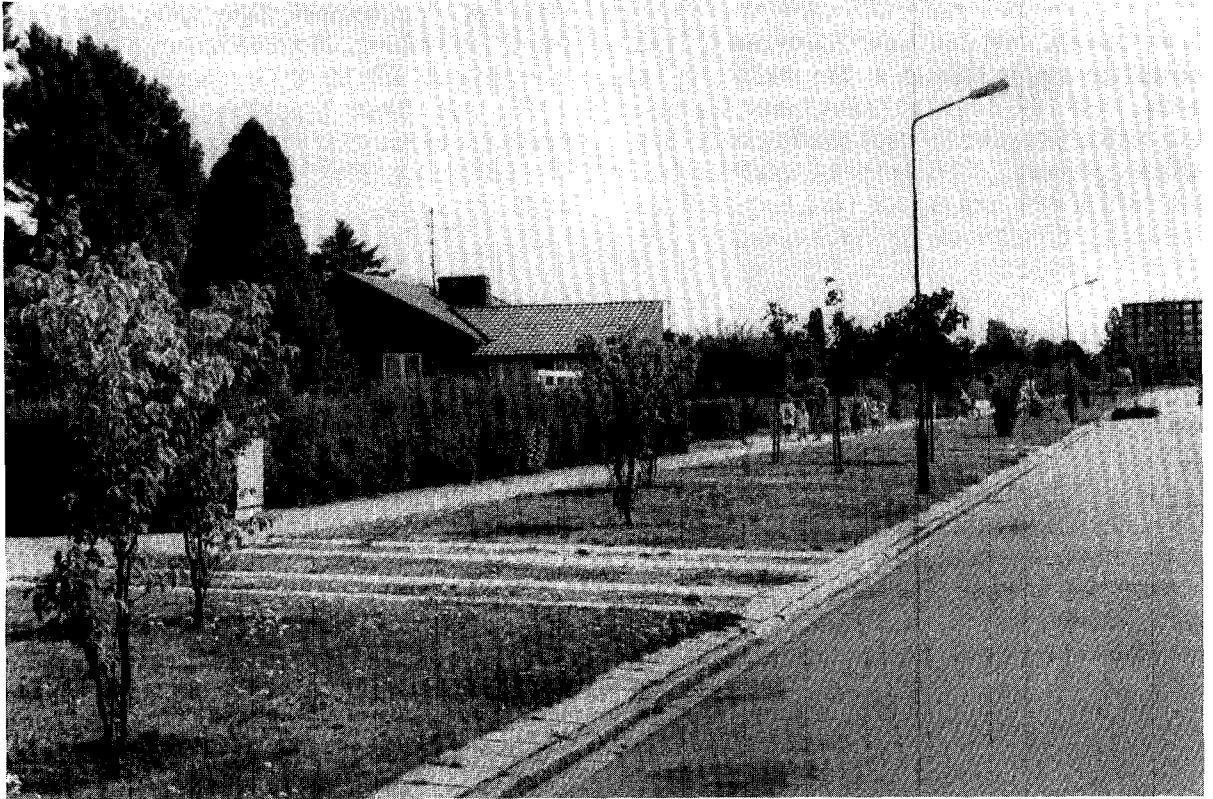
Figure 8. Vanåsgatan one year after replanting with *Acer platanoides* 'Schwedleri' where there was enough space and with *Cercidiphyllum japonicum* and *Prunus sargentii*.
