STREET TREE INVENTORY IN MEXICO CITY

by Alicia Chacalo, Alejandro Aldama and Jaime Grabinsky

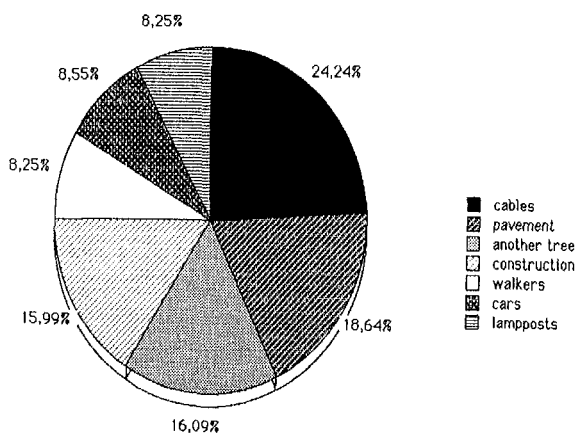
Site evaluation. Among the variables considered as tree interferences, electric and telephone lines and pavement were the most frequent (Fig.2). Utility lines were in 48% of the trees and were 24% of all the interferences. Pavement accounted for 19% of the interferences but affected 37% of the trees. Many trees had two or more interferences that required immediate attention.

Fig. 2. Distribution of tree interferences.

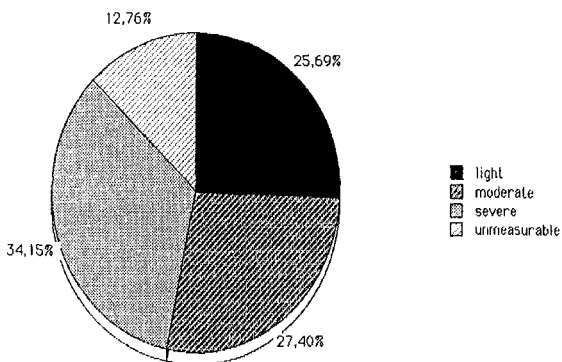
The soil compaction around 13% of the trees could not be measured using the iron rod technique (Fig.3), and for another 34% it was severe. In all, 47% of the individuals were affected strongly by this problem. From all site measurements and observations, approximately 20% of the trees live

Fig. 3. Soil compaction.

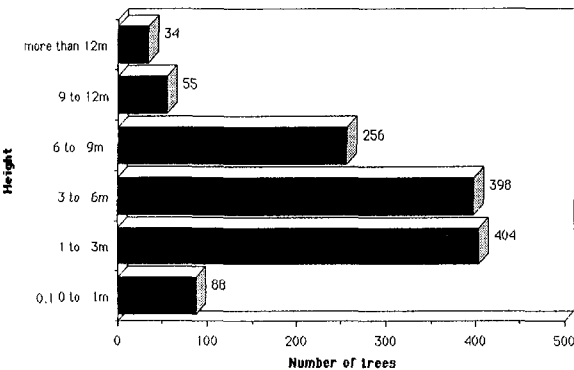
The dendrometric characteristics considered were the diameter, the height and the number of trunks. Eighty eight trees measured less than a meter in height (Fig. 5) and 702 trees had a diameter of less than 15 centimeters (Fig.6). This shows a young population of trees in this city, a big planting effort by the government and by citizens in the recent past, but also a low survivability

Fig. 5. Distribution of the number of trees with respect to height.

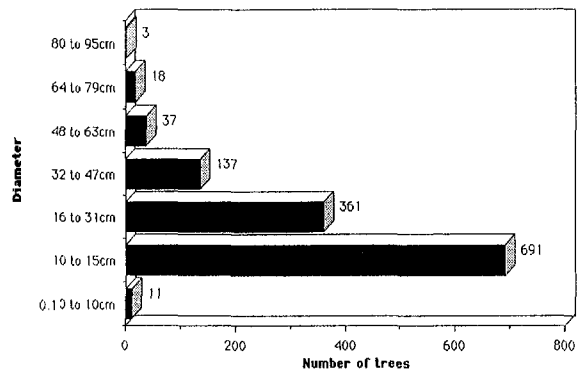
Fig. 6. Distribution of the number of trees with respect to diameter of the trunk.
