# WINDTHROW ALONG ELECTRICAL DISTRIBUTION LINES IN A RURAL SETTING

by Jean-Claude Ruel and Daniel Pin

**Abstract.** A blowdown survey was conducted along electrical distribution lines in a rural setting in order to identify the most important variables in estimating blowdown hazard. The variables usually involved in such an estimation did not prove very powerful in explaining blowdown density. In fact, blowdown was more related to the vegetation characteristics, namely size, species and vigour. This can be explained by an overriding effect of those characteristics in poorly managed stands that can be overmature and of low vigour. Specific studies are then needed to include those variables in blowdown hazard assessment.

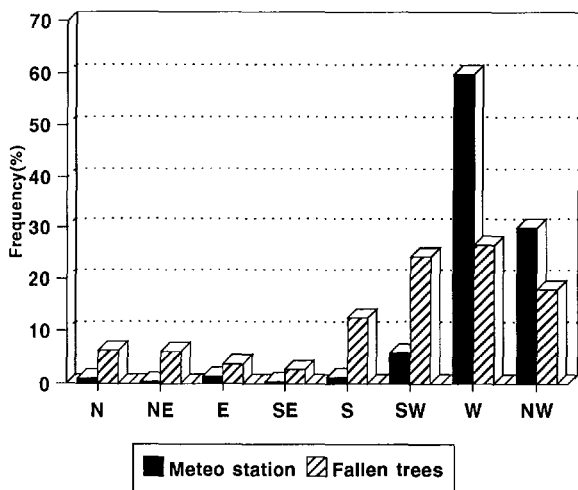
**Figure 2. Frequency directions of windspeeds over 40 km/h recorded at the nearest meteorological station and of actual winds that caused blowdown, as inferred from fallen trees.**

The analysis of the field survey reveals some similarities between the apparent direction of the damaging winds, as inferred from the direction of fallen trees, and the occurrence of strong winds recorded at the nearest meteorological station, located 25 km from the study area (Figure 2). Fall direction was generally in an eastern direction, indicating westerly damaging winds. This is in relative agreement with the occurrence of windspeeds over 40 km/h. This result would sug-

gest that meteorological station data could provide a rough estimate of the direction of potentially damaging winds over an area. However, significant differences ( $p < .005$ ) were observed between both frequency distributions. These differences are probably related to the effect of topography on wind behaviour (4).

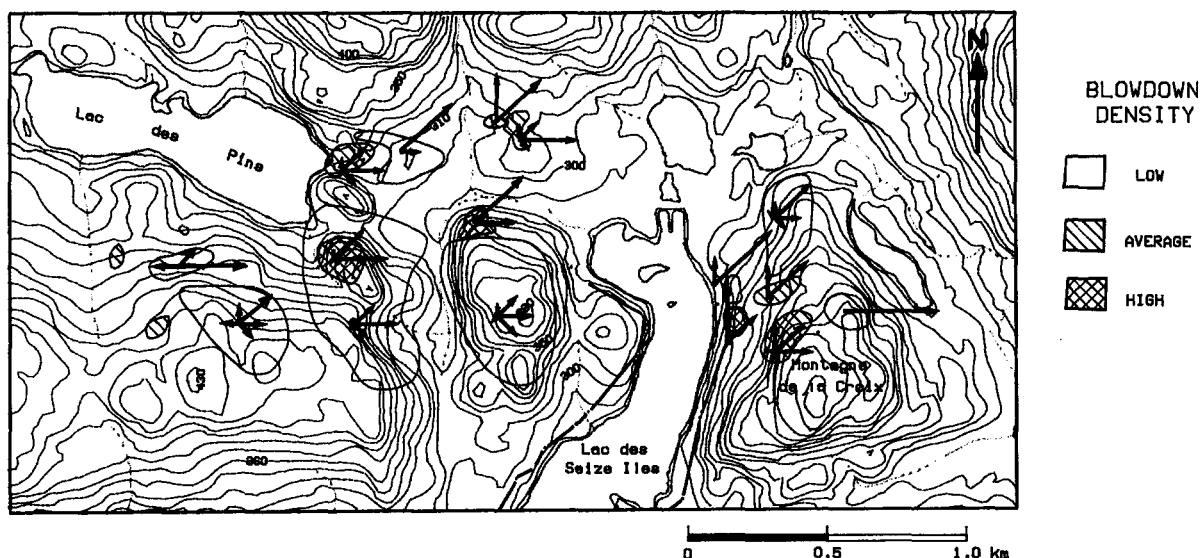
**Figure 3. Localization of blowdown from aerial photographs. Arrows are proportional to the frequency of treefall in each direction.**

on blowdown density was found. To further investigate the impact of topography on wind, it was necessary to resort to the aerial photographs. Figure 3 shows these results. A dominant easterly fall direction emerges, but with strong variations, this direction becoming northerly or north-easterly in the Lac-des-Seize-Iles area. Many high density zones were mapped, one such zone occurring east of Lac-des-Pins. This zone is associated with a funnelling effect at the end of the lake, further emphasized by the presence of a steep slope. It is well known that wind speed increases when flowing over an obstacle (4). On the western side of Lac-des-Seize-Iles, an intermediate concentration of blowdown (point A) can be seen where fall direction is northerly, parallel to the lake long axis. This agrees with the general observation that, in rugged topography, wind tends to follow the valleys (8). On top of Montagne-de-la-Croix, an area (point B) with no preferential fall direction is seen. This could correspond to an increase in turbulence behind an exposed crest (4). These results suggest that, even though potentially damaging wind direction can be roughly estimated by data from meteorological stations, reliable prediction at a local level would require a better understanding of the effect of topography on wind direction and strength.

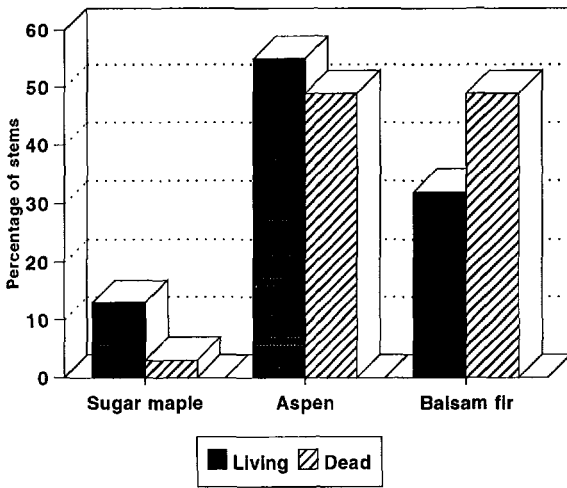
**Figure 4. Species frequency in living and dead trees.**

Four species accounted for 84% of the dead trees sampled. These were: balsam fir, aspen (bigtooth and quaking) and sugar maple. Other species were of relatively minor importance. The species frequency of dead trees differs significantly from that of living trees (Figure 4). Balsam fir comprised 49% of the total number of dead stems and 32% of the living stems. Sugar maple comprised 3% of the dead stems and 13% of the living stems. This seems to demonstrate a differential vulnerability of those species to windthrow. An effect of cover type was not seen in the preceding analysis of stand-level factors probably because many other factors also varied concurrently. We nevertheless can expect sugar maple stands to be less vulnerable and balsam fir stands to be more vulnerable. Sugar maple is generally believed to be a deeper rooting species and less prone to decay than balsam fir (5).

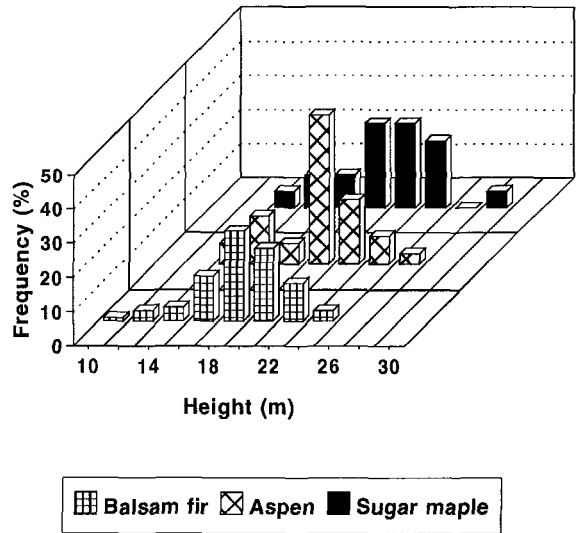
**Figure 5. Height distribution by species in fallen trees.**

Univariate statistics of fallen trees were compiled to characterize this population. In this case study, which should be viewed as a first step, the median was chosen to represent a certain critical height or diameter. Figure 5 shows the frequency distribution of height by species and Figure 6 displays the same information about diameter. Median values are presented in Table 1. Balsam fir becomes very affected by blowdown when it reaches 18 m while this occurs around 20 or 22 m for the other species. The height of fallen balsam fir and sugar maple trees is significantly greater than that of living trees (Table 2). This was not the case with aspen since some stands, with very tall trees, were found in sheltered situations. The results for the two former species indicate that stand height should be considered as a good indicator of windthrow hazard. The effect of tree diameter follows the same trend and the same conclusions can be drawn (Figure 6 and Table 2).

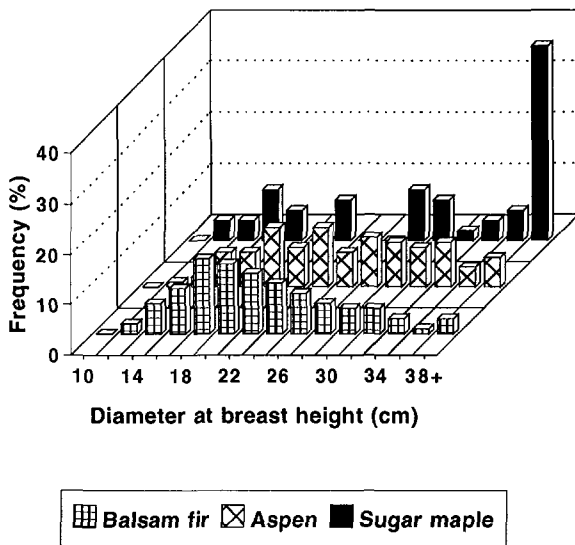
**Figure 6.** Diameter distribution by species in fallen trees.
