DEFENDING STREET TREES AGAINST ROAD SALT IN DENMARK¹

by Niels Hvass

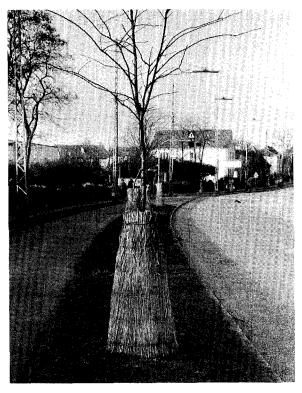
Fig. 2. This straw mat is useless. We call it a stem warmer.

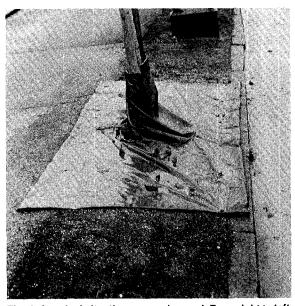
Fig. 4. A typical situation on a major road. From right to left: road, curb with drain, growing site (shoulder), bicycle track, curb with drain, sidewalk. In this experiment a heavy plastic poncho is tied to the tree and nailed to the ground. This protection is meant to lead water away from the growing area.

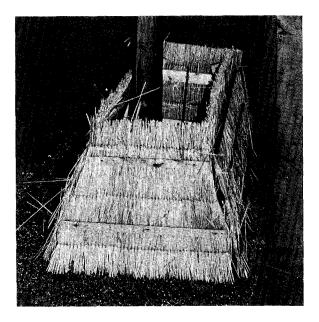
Fig. 5. This is the same road as Fig. 4. So far, the system with straw mats is the one most recommended. It gives good protection against salt and it is reasonably aesthetic. New models will have a plastic liner which will lead the water over the curb into the gutter.

and to lead salty slush from vehicles and sweepers into the drain. Copenhagen city authorities are right now in a testing phase, and the photos show some of the tests. The ideas are tested both for efficiency and to estimate the aesthetic impression as well. Straw mats approximately 60 cm high with a plastic liner sewn on seem at present most promising. The plastic liner is inside the mat and is meant to ensure that water runs to the outside of the curbstone.
