# WINDTHROW ALONG ELECTRICAL DISTRIBUTION LINES IN A RURAL SETTING

by Jean-Claude Ruel and Daniel Pin

**Abstract.** A blowdown survey was conducted along electrical distribution lines in a rural setting in order to identify the most important variables in estimating blowdown hazard. The variables usually involved in such an estimation did not prove very powerful in explaining blowdown density. In fact, blowdown was more related to the vegetation characteristics, namely size, species and vigour. This can be explained by an overriding effect of those characteristics in poorly managed stands that can be overmature and of low vigour. Specific studies are then needed to include those variables in blowdown hazard assessment.

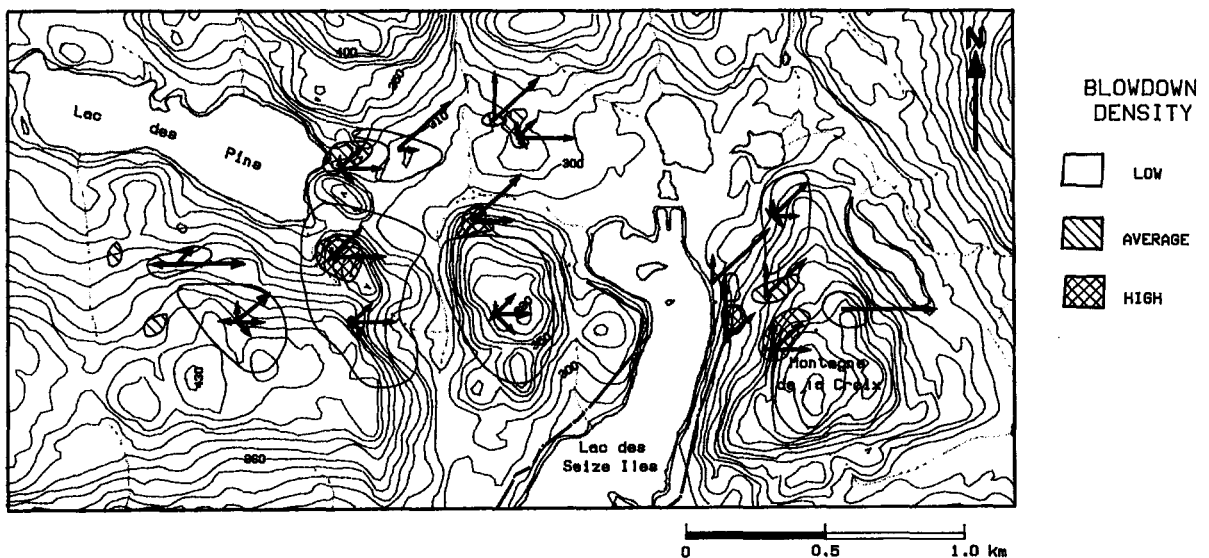
**Figure 3. Localization of blowdown from aerial photographs. Arrows are proportional to the frequency of treefall in each direction.**

on blowdown density was found. To further investigate the impact of topography on wind, it was necessary to resort to the aerial photographs. Figure 3 shows these results. A dominant easterly fall direction emerges, but with strong variations, this direction becoming northerly or north-easterly in the Lac-des-Seize-Iles area. Many high density zones were mapped, one such zone occurring east of Lac-des-Pins. This zone is associated with a funnelling effect at the end of the lake, further emphasized by the presence of a steep slope. It is well known that wind speed increases when flowing over an obstacle (4). On the western side of Lac-des-Seize-Iles, an intermediate concentration of blowdown (point A) can be seen where fall direction is northerly, parallel to the lake long axis. This agrees with the general observation that, in rugged topography, wind tends to follow the valleys (8). On top of Montagne-de-la-Croix, an area (point B) with no preferential fall direction is seen. This could correspond to an increase in turbulence behind an exposed crest (4). These results suggest that, even though potentially damaging wind direction can be roughly estimated by data from meteorological stations, reliable prediction at a local level would require a better understanding of the effect of topography on wind direction and strength.

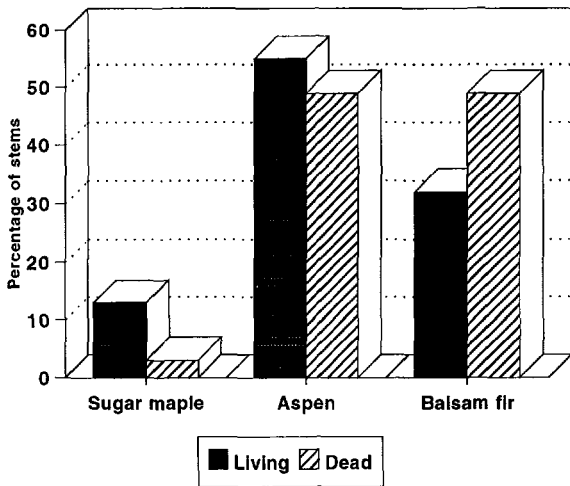
Figure 4. Species frequency in living and dead trees.

Four species accounted for 84% of the dead trees sampled. These were: balsam fir, aspen (bigtooth and quaking) and sugar maple. Other species were of relatively minor importance. The species frequency of dead trees differs significantly from that of living trees (Figure 4). Balsam fir comprised 49% of the total number of dead stems and 32% of the living stems. Sugar maple comprised 3% of the dead stems and 13% of the living stems. This seems to demonstrate a differential vulnerability of those species to windthrow. An effect of cover type was not seen in the preceding analysis of stand-level factors probably because many other factors also varied concurrently. We nevertheless can expect sugar maple stands to be less vulnerable and balsam fir stands to be more vulnerable. Sugar maple is generally believed to be a deeper rooting species and less prone to decay than balsam fir (5).

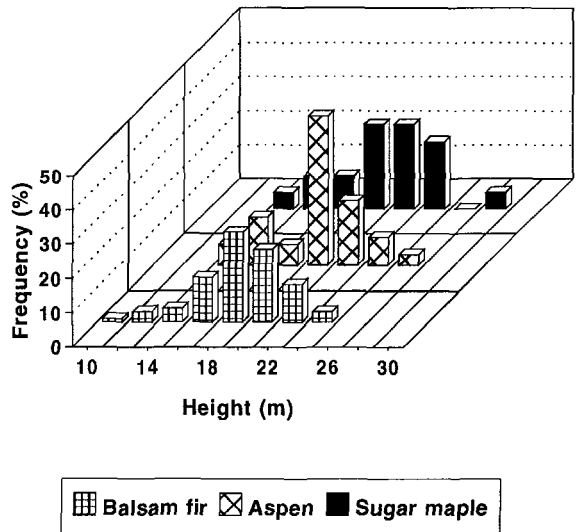
Figure 5. Height distribution by species in fallen trees.

Univariate statistics of fallen trees were compiled to characterize this population. In this case study, which should be viewed as a first step, the median was chosen to represent a certain critical height or diameter. Figure 5 shows the frequency distribution of height by species and Figure 6 displays the same information about diameter. Median values are presented in Table 1. Balsam fir becomes very affected by blowdown when it reaches 18 m while this occurs around 20 or 22 m for the other species. The height of fallen balsam fir and sugar maple trees is significantly greater than that of living trees (Table 2). This was not the case with aspen since some stands, with very tall trees, were found in sheltered situations. The results for the two former species indicate that stand height should be considered as a good indicator of windthrow hazard. The effect of tree diameter follows the same trend and the same conclusions can be drawn (Figure 6 and Table 2).
