EFFECT OF BASEMENT SUMP PUMP EFFLUENT ON THE GROWTH AND PHYSIOLOGY OF URBAN BLACK ASH AND GREEN ASH ORNAMENTAL TREES

by Cameron G. Lait¹, Suomal Saelim², Janusz J. Zwiazek², and Yao Zheng

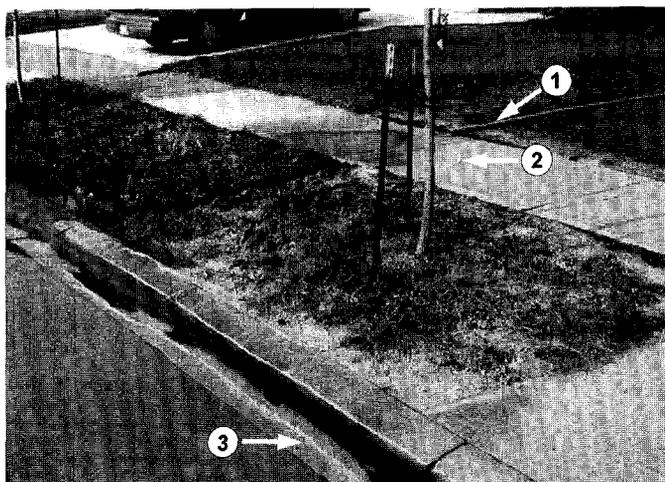
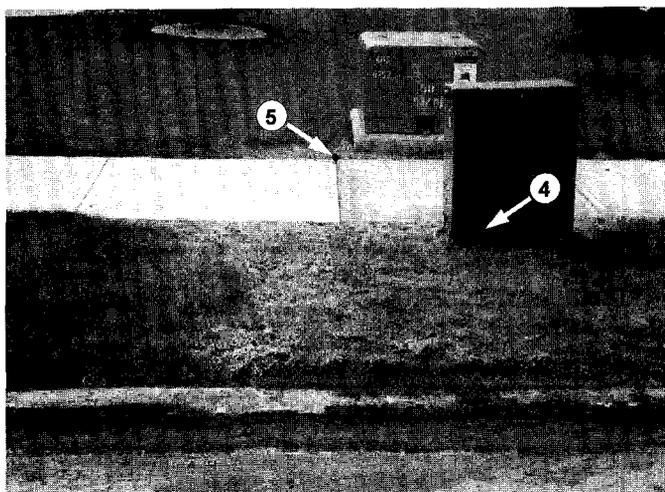
Figure 1. Positioning of sump pump effluent discharge hose at edge of sidewalk in proximity to boulevard. (A) New discharge hose (arrow 1) is visible prior to sod grass installation; salt residues (arrows 2 and 3) are evident on sidewalk and roadway after evaporation of effluent. (B) Damage caused by sump pump effluent seen as browning of boulevard grass and corrosion of a metal utility box (arrow 4) resulting from a hidden discharge hose (arrow 5).

Figure 1 shows the positioning of sump pump effluent-discharge hoses in proximity to boulevards, salt residues that were left behind after evaporation of effluent, and some of the damage to vegetation and a steel utility box caused by the effluent.

Sump pump activity at the Deer Ridge site was very high, and sump pump effluent collected from a local basement pump had an electrolytic conductivity of 10.2 dS m^{-1} . The high electrolytic conductivity of sump pump effluent suggests very high ion content, which likely contributed to the high levels of ions measured in soil from the Deer Ridge boulevards (Table 2). This might account for injury symptoms observed on boulevard ornamental trees (Figure 2A) and grass (Figure 1B) in the area.

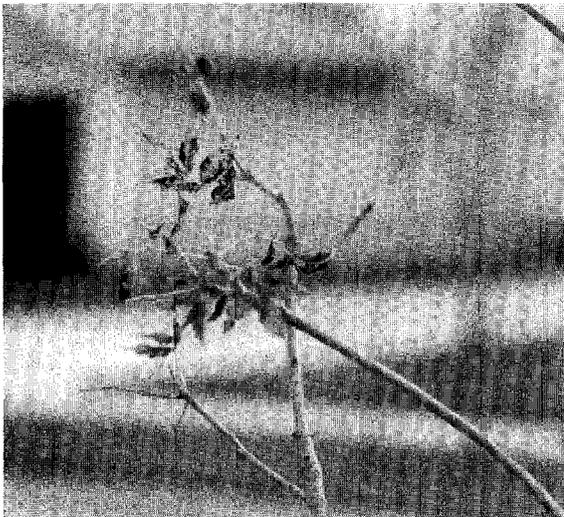
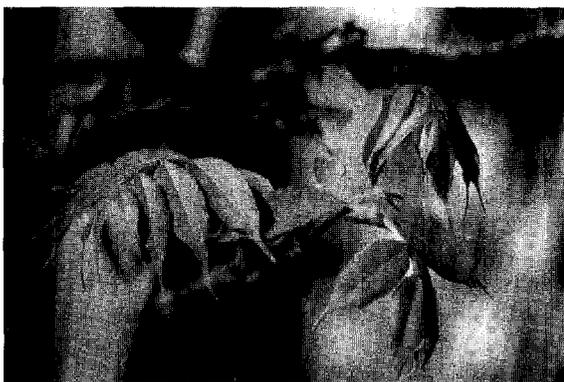
Figure 2. Appearance of late spring foliage on transplanted black ash trees at two different sites. (A) St. Albert-Deer Ridge, where sump pump effluent was discharged into boulevards. (B) Sherwood Park-Nottingham, where there was no sump pump effluent discharge.

stunted and showed signs of necrosis when compared to black ash trees located away from sump pump effluent discharge (Figure 2). New shoot die-back, leaf tip or leaf marginal browning, and many other injury symptoms exhibited by black ash trees located in proximity to sump pump effluent dis-

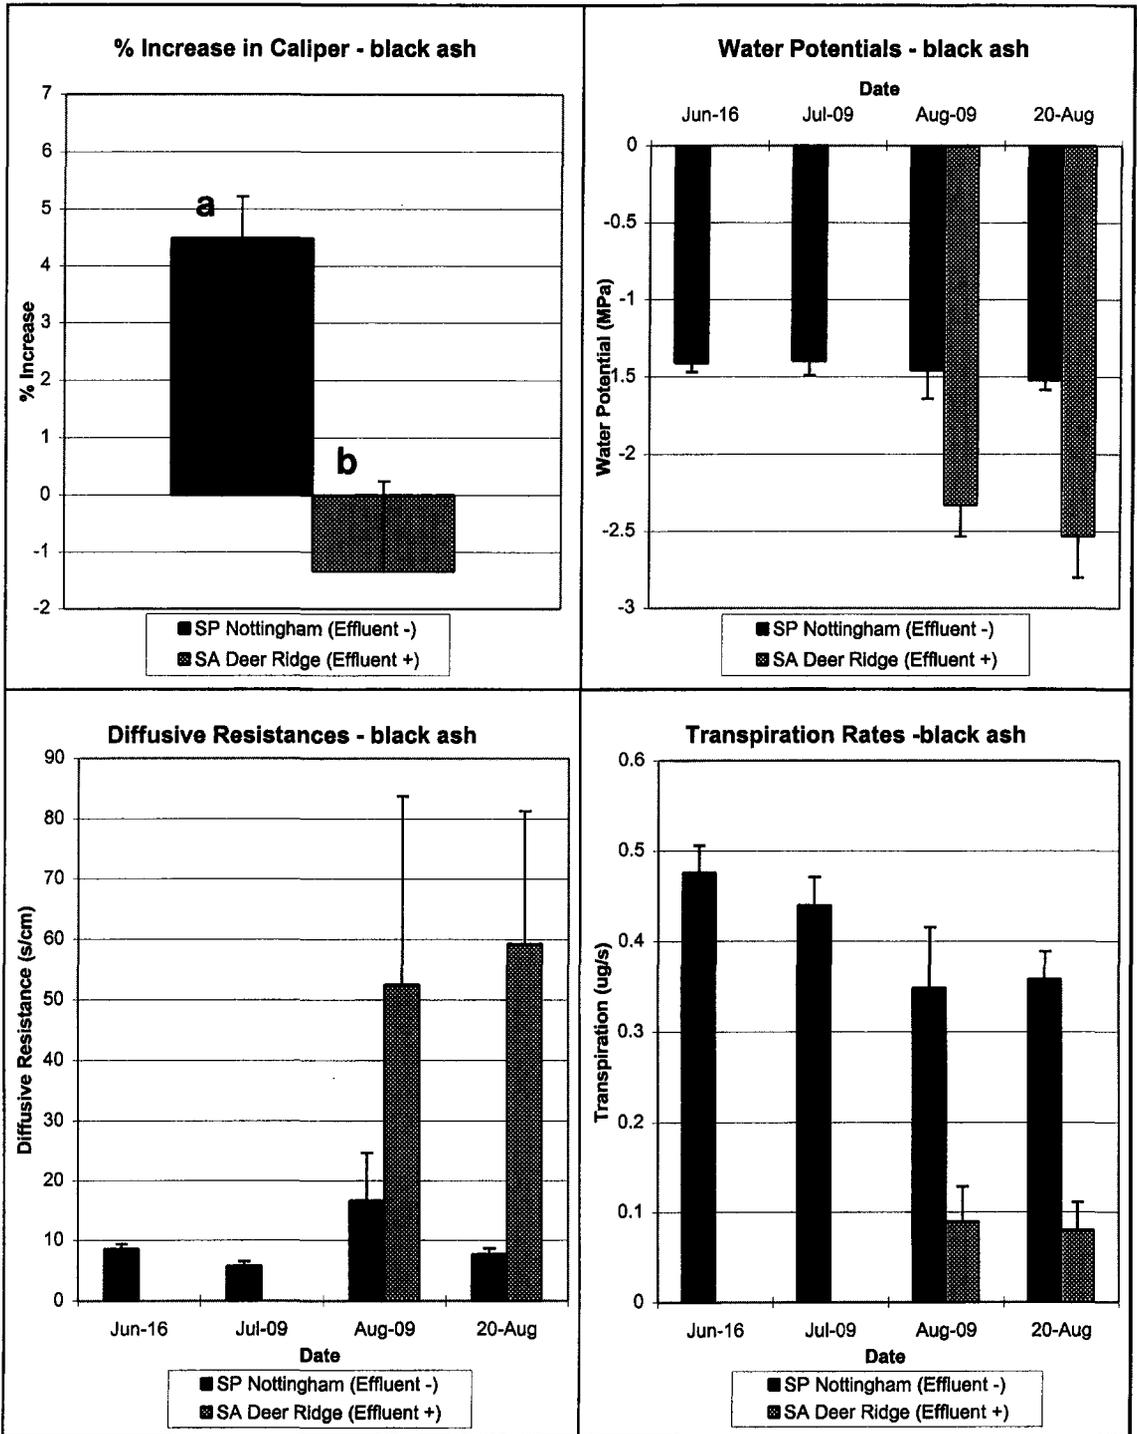
Figure 3. Caliper growth, leaf petiole water potentials, and gas exchange of black ash trees irrigated with sump pump effluent discharged into boulevards (effluent+), and black ash trees not irrigated with sump pump effluent (effluent-). Bars are means \pm standard error. Bars with the same letter are not significantly different.

UMA Planning & Design group measured representative soil electrolytic conductivity and major ion levels at several locations, near our study trees, in the Deer Ridge area (Table 2). Soil electrolytic conductivities and levels of sodium and sulfate varied widely but were among the highest at the St. Albert, Deer Ridge streets Donald Place and Delage Crescent. Both sites contained boulevard ornamental trees used in this study, and had abnormally high tree mortality rates where sump pump effluent was discharged directly into boulevards. At the Deer Ridge (Delage Crescent) site, 70% of the black ash study trees died before the end of the experiment, while the remaining 30% exhibited severely stunted growth and delayed spring bud flush. In black ash trees, altered water relations and significantly lower mean percent caliper increase (two-sample t-test significance level 0.01, $P < 0.005$) were recorded at the St. Albert Deer Ridge site (effluent+) compared to trees at the Sherwood Park Nottingham site (effluent-) (Figure 3).

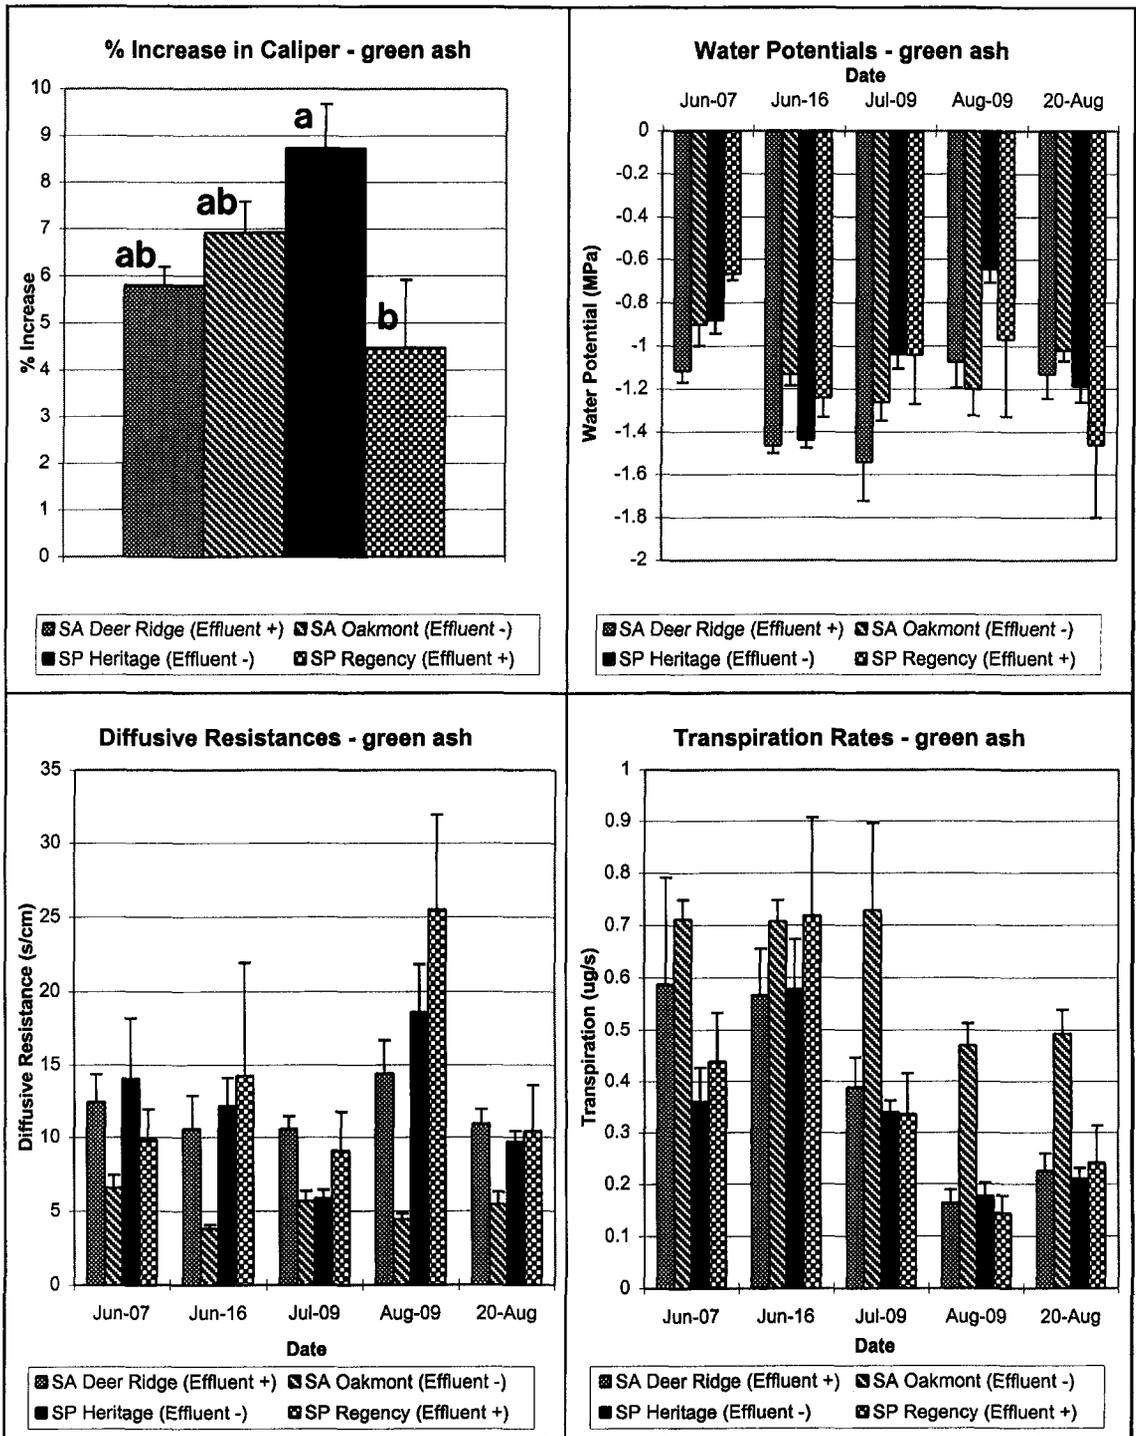
Figure 4. Caliper growth, leaf petiole water potentials, and gas exchange of green ash trees irrigated with sump pump effluent discharged into boulevards (effluent+), and green ash trees not irrigated with sump pump effluent (effluent-). Bars are means \pm standard error. Bars with the same letter are not significantly different.

more than green ash trees at the Regency (effluent+) site. Green ash mean caliper percent increases at the two St. Albert sites (effluent+/-) were not significantly different. Green ash trees appeared to be more resistant to the negative effects of sump pump effluent discharge than black ash trees, as suggested by similar physiological responses between green ash trees subjected to irrigation with sump pump effluent and those that were not (Figure 4). However,
