JOURNAL OF ARBORICULTURE

STUDIES OF SALT-INDUCED DAMAGE TO ROADSIDE PLANTS IN ONTARIO¹

by G. Hofstra, R. Hall and G.P. Lumis

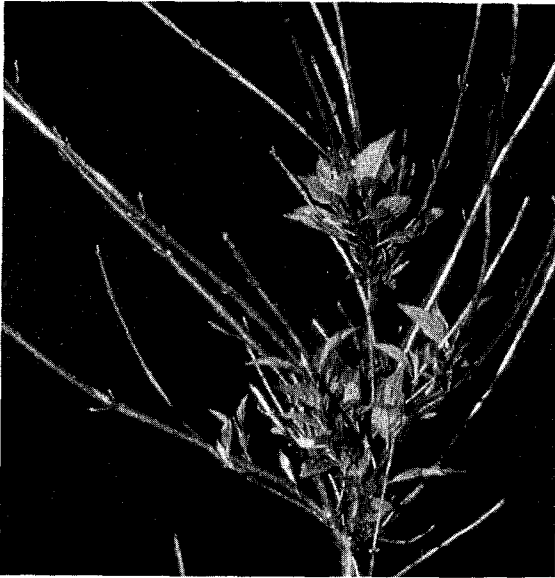
Fig. 6. Branches of red-osier dogwood killed by salt and leafing out from the bases of the branches.

Damage on deciduous trees and shrubs is not evident until the buds begin to open in the spring. Injured buds do not open and whole branches may be devoid of leaves (Fig. 6). Affected branches often leaf-out later from dormant or adventitious buds near the base of the twigs giving the tree a tufted appearance (Fig. 7) (Lumis et al. 1973).

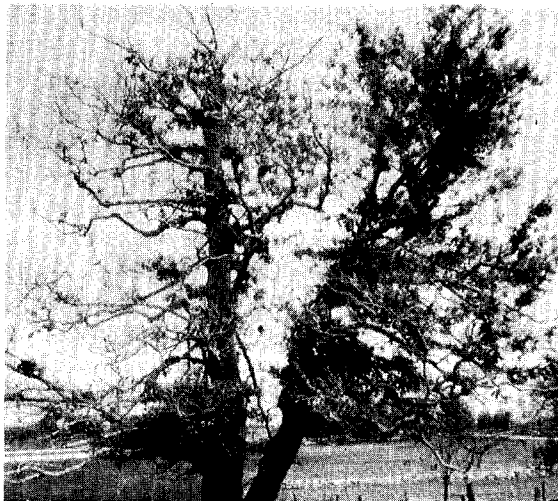
Fig. 7. A lone beech tree close to a four-lane highway. Note the tufted appearance of the tree and the greater injury on the side of the tree facing the highway.

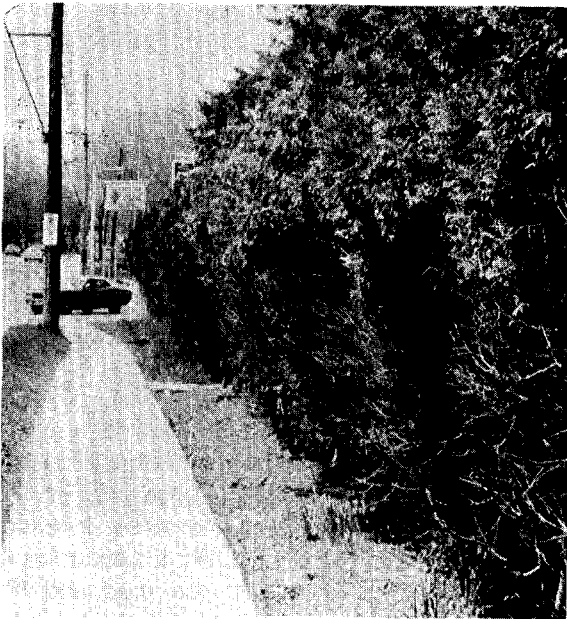
Fig. 9. A cedar hedge close to a busy street. All leaves in the splash zone have died and dropped off.

The pattern of injury is usually distinct and is a useful guide to identifying the cause of injury. Plants are much more severely damaged on the sides facing roadways, very apparent in cedar hedges (Fig. 9). There is usually a distinct injury gradient with distance from the road and the greatest injury occurs on the windward side of the road. Where branches were covered by snow usually no injury occurs, the snow line often being very apparent on evergreens. The tops of tall trees are unaffected or affected less, the greatest injury occurring within a couple of metres from the ground depending on elevation in relation to the road.

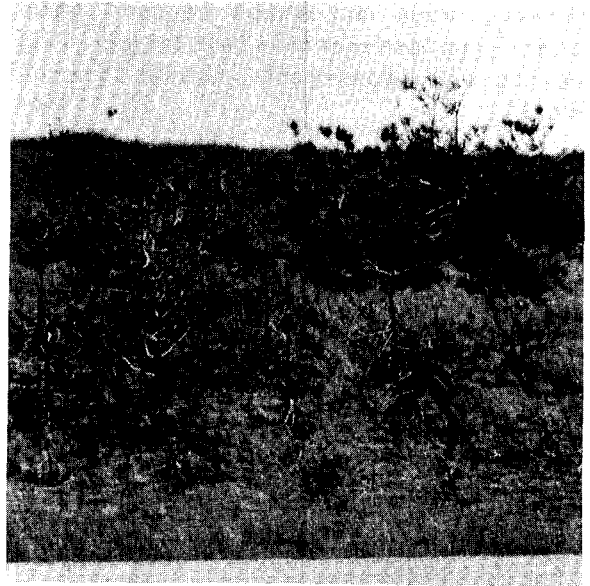
Fig. 10. Scots pine on the south side of a four-lane highway. Trees are approximately 15 years old. Note their stunted, tufted and misshapen appearance.

The greatest effects on growth are on evergreens because the leaves are weakened or killed. Trees like Scots pine can become severely stunted and misshapen (Fig. 10). Others become one-sided as needles and branches are continually killed on the road side of the tree.

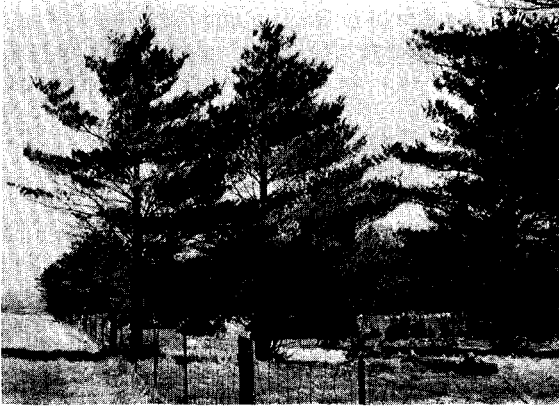
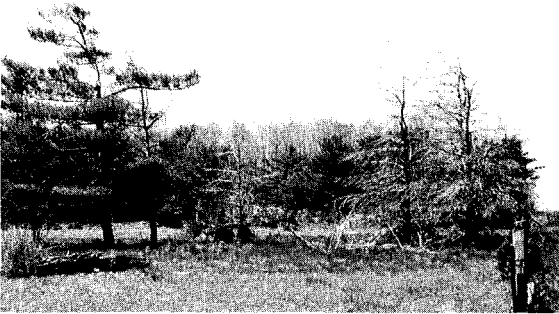
Fig. 11. Eastern white pine trees approximately 30 m from the highway. (above) Trees next to the fence show severe damage on the side facing the road. (below) The same trees are dead 8 years later. Trees further back are becoming more exposed and are showing more injury.

One of the main effects on pines is that the needles die prematurely and drop off reducing the photosynthetic capacity of the tree. The amount of new growth becomes less and less, causing the tree to weaken and eventually die (Fig. 11a and b). Growth rings of affected trees become thinner with time (Fig. 12). The irregularity in the thickness from year to year reflects both the growing conditions and the differences in the amount of injury from year to year. Only trees close to roadways are greatly affected (Hall et al. 1972).
