# EFFECTS OF ROAD DISTANCE AND PROTECTIVE MEASURES ON DEICING NaCl DEPOSITION AND SOIL SOLUTION CHEMISTRY IN PLANTED MEDIAN STRIPS

**Abstract.** The deposition pattern of deicing salt and the resulting concentrations in the soil water were determined in planted median strips of two major approach roads with speed restrictions of 70 kmh (43.5 mph) in Copenhagen, Denmark. The objectives were to evaluate the effect of distance from the roadside and to test different straw mat protective measures. Deposition and soil water concentrations of sodium chloride (NaCl) decreased significantly within 2 m (6.6 ft) from the roadside compared to areas farther away. Straw mats mounted like a skirt around the tree stem did not constitute a proper protection against salt spray or splash and high salt concentrations in the soil water. In contrast, protection with straw mats on all sides of the trees resulted in a small but measurable effect. The highest concentrations of NaCl in the soil water were seen during the winter. However, there was a strong tendency of elevated concentrations persisting throughout the subsequent summer, which suggests that serious salt stress exists on the trees during the

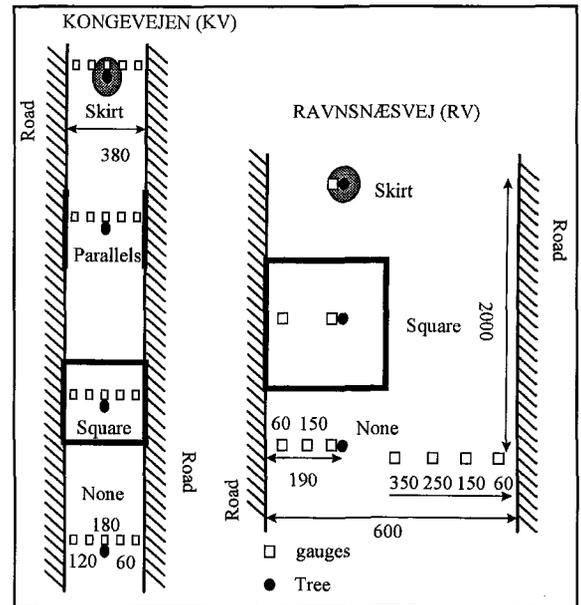
Figure 1. Experimental area at the median strips at Ravnsnæsvej (RV) and Kongevejen (KV), Copenhagen, Denmark. At RV, only one of the tree groups is shown.

At RV, three groups of trees were included. Two types of straw mat configurations were tested against a control without protection. One protective measure was a box or square around the tree. The dimensions of the square were approximately 3 × 3 m (10 × 10 ft). The other protective measure was a skirt around the tree trunk. The height of the skirt was 1.2 m (4 ft). At the soil surface, the diameter of the skirt was approximately 1.0 m (3.3 ft). At the top, the skirt was wound tightly around the trunk, but stem flow was not prevented.

The trees at KV were generally unhealthy, suffering from premature autumn coloring and twig and limb dieback, and most trees showed a characteristic witch's broom structure. At this site, three types of straw mat configurations were compared to a control (Figure 1). Besides the box or square and the skirt protective measures, an arrangement of parallel straw mats (parallels) was included. Except for the mats transversing the strip (connecting the mats run-

ning parallel along the roadsides), this setup was identical to that of the square. All sides of the square as well as of the parallel were 3.8 m (12.5 ft) long. The skirt had the same dimensions as on RV.

At both sites, the straw mats were lined with plastic. On the mats facing the road, the plastic protruded from the lower edge of the mats to ensure draining directly to the road. According to local authorities, the height of the mats was allowed to be only 0.55 m (1.8 ft) to prevent blocking the views of vehicle drivers. The protective mats were mounted on 15 November prior to salting and taken down on 15 April after salting was concluded for the season.

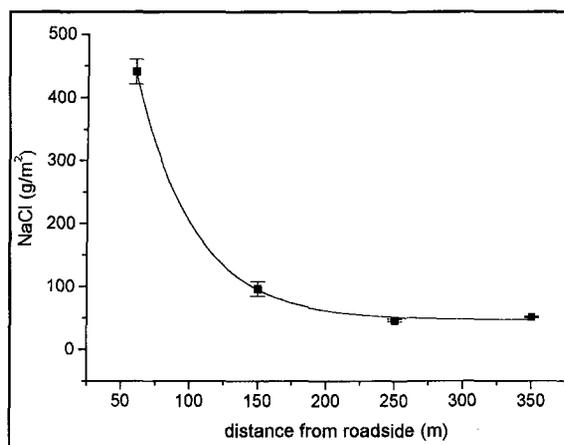
**Figure 2. Deposition of road salt (NaCl) at different roadside distances at the median strip at RV. Error bars are calculated as standard errors ( $n = 3$ ). The presented curve is the best first-order exponential fit.**

The salt deposition in the two years was comparable in magnitude, although the distribution varied with the largest amount deposited in February 1997 and 1998 and in March 1998 and 1999. Figure 2 illustrates the average yearly deposition at RV at different roadside distances. The mean deposition in the two years was  $441 \text{ g/m}^2$  at 0.6 m (2 ft),  $96 \text{ g/m}^2$  at 1.5 m (5 ft),  $46 \text{ g/m}^2$  at 2.5 m (8.2 ft), and  $51 \text{ g/m}^2$  at 3.5 m (11.5 ft). Beyond 2 m (6.6 ft), no significant change in the salt load could be observed. The slightly larger deposition at 3.5 m compared to that at 2.5 m could probably be explained by additional deposition from the opposite roadside (distance approximately 2.5 m). The largest deposition definitely occurred close to the roadside and seemed to decline exponentially toward the middle of the median strip.

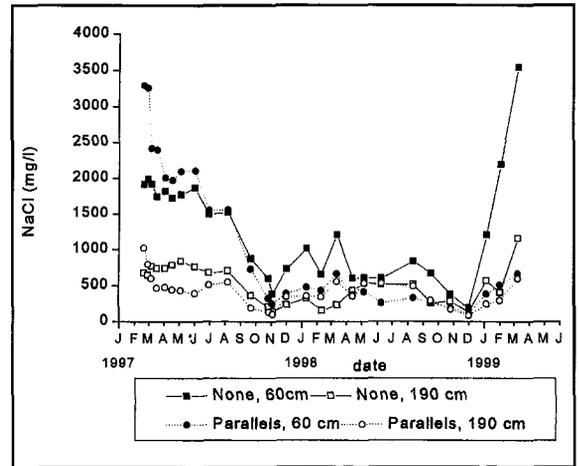
Figure 3. Concentration of NaCl in the soil water at the median strip at KV. Concentraions are given for distances of 60 an 190 cm (24 and 75 in.) from the roadside without protective measures as well as with a protection measure of parallel straw mats.

During the study period, soil water salt concentrations were high, between 20 and 100 times as high as under forest conditions in Denmark (Pedersen 1993; Pedersen and Bille-Hansen 1995). Even though the concentrations peaked in the salt application period during winter dormancy (Figure 3 and Figure 4), the concentrations remained high during the period of growth (Table 3). Despite abundant precipitation (200 to 300 mm [7.9 to 11.8 in.]), there was a tendency to only insignificantly decrease concentrations during spring followed by increasing concentrations during the summer and a pronounced decrease in the late autumn.

The salt leaching in spring was not complete. No leaching occurred during the summer period; instead, the salt in the soil water became concentrated as a result of evapotranspiration. Most of the NaCl was not leached until the rainy autumn; the soil water then reached concentration levels of about 100 mg/L.

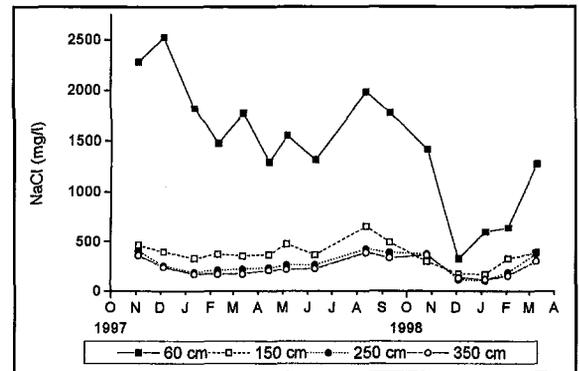
Figure 4. Concentration of NaCl in the soil water at different distances at RV (without protective measures).

NaCl concentrations in the soil water mirrored the deposition figures. Very high concentrations occurred close to roadside. The average NaCl concentrations for the whole study period were 1,595 mg/L at 0.6 m (2 ft), 384 mg/L at 1.5 m (5 ft), 248 mg/L at 2.5 m (8.2 ft), and 235 mg/L at 3.5 m (11.5 ft) from the roadside. As with deposition, the soil water concentrations seemed to decline exponentially toward the middle of the median strip, with only insignificant changes beyond 2 m (6.6 ft).
