STREET TREES IN HIGH-DENSITY URBAN HONG KONG

by C. Y. Jim

Abstract. High-density urban Hong Kong has a small population of street trees. A survey of 930 trees in two districts provide information on tree characteristics and for management. Of the 55 species encountered, few are numerically dominant and currently cultivated. The rare species are mainly woodland or garden relics. Species selection is shifting from native/large to introduced/small. Some popular species are not quite suitable for streets; a few rare voluntary species perform well. Most trees are concentrated along a few roads where growth space is available. Plantable space is a major bottleneck. The distribution of trees by growth type, position, and proximal landuse are discussed. Most trees have narrow crowns and are short-statured, suggesting a youthful population and/or a recent trend to plant small species. Two-thirds have arboricultural problems. Lack of tree data and of regular inspections make planning for tree care difficult. Maintenance is grossly inadequate due to lack of skilled workers. The poor tree health and defects are likely to persist.

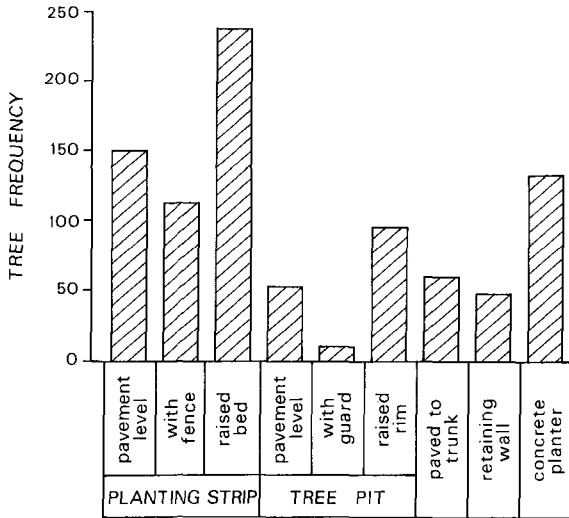
Fig. 3. The frequency of trees by nine types of growth space.

Types of growth space. Although nine types of street growth space are common in Hong Kong, about half of the trees are found in one of the three types of planting strips (Fig. 3). Most of these strips are narrower than 2 m but they are, by local standards, very generous. Most of these strips are along the few roads through low density areas, or new roads where space was reserved, by new planning standards, for amenity planting. Very few roads have more than one line of trees. About 16% of the trees are reared in pits, most of which are undersized and not equipped with grilles.

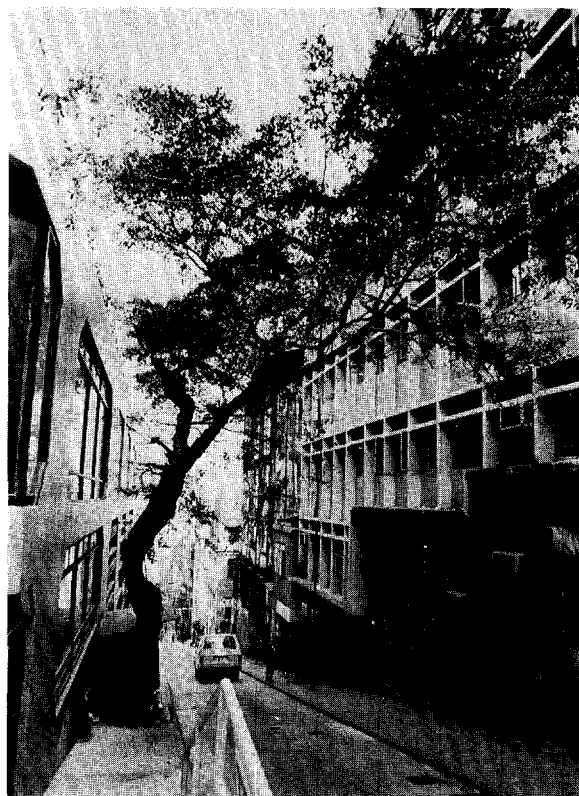
Fig. 5. This *Ficus microcarpa* (Chinese Banyan) has been severely deformed and left trapped on a narrow sidewalk without a tree pit as a result of building redevelopment.

Figure 4 shows the trees' growth positions. Most are on property or curb side of the sidewalk. But some straddle the sidewalk obstructing pedestrians due to road alignments (Fig. 5). About 13% are in the few recently built central dividers.

Physical restrictions. Above-ground space is very restricted for 7% of the trees. Physical obstacles include buildings (especially with awnings), vehicles, signs and lamp-posts (Fig. 1 and 5). The trees' crowns are incomplete. Wrong species, mis-siting, typhoon damage, construction, and general decline and dieback also cause this. Building or road development often has priority over trees' crowns (Fig. 1 and 5). Selection and siting cannot preclude landuse change.
