Tree-related Electric Outages Due To Wind Loading

Abstract. In the aftermath of a wind storm that interrupted service on more than 40% of Puget Sound Energy's transmission system, the regulator ordered an investigation to evaluate options for hardening the electric system. The initial phase of the study quantified the extent of tree exposure along the transmission system and examined the correlation between various field measurable variables and tree-caused outage frequency. This phase of the work correlated 10 years of wind data with 10 years of outage data. Tree failure rates were calculated and used to model tree-caused outage expectations based on wind speed. Models were developed to assess the outage impact of interventions that reduce the transmission system exposure to trees.

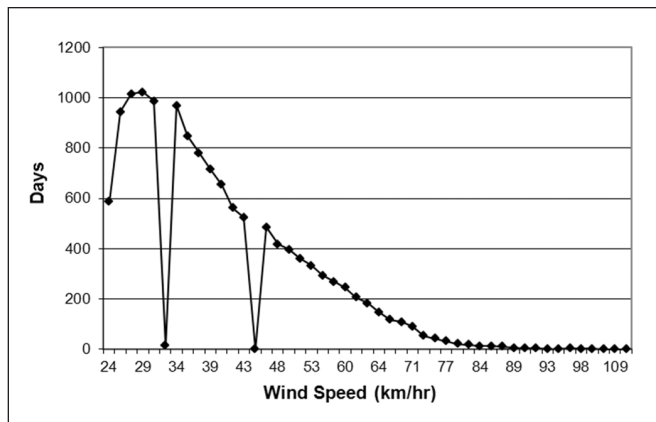
Figure 1. PSE service territory ten-year wind frequency (1998–2007). Note: Y-axis is number of days when winds of a specific speed were experienced at one or more of the nine airfields.

Graphics to represent the frequency of wind events and outages associated with wind speed were developed. The troughs in the data at 32 and 45 km/hr (Figure 1), and the saw tooth pattern or variability (Figure 2), made it apparent that a modeling approach was needed to smooth out the data. Exponential regression was used to develop algorithms to predict tree-related outage events.

It was found that over the ten-year period, 18% of the days had sustained wind speeds of less than 24 km/hr. Fifty-six of the 265 tree-caused transmission interruptions occurred under these conditions. Without detailed data on winds below 24 km/hr, the shape

of the frequency distribution is not explicit, but there is enough data to know that it is a positively skewed distribution (Figure 1).

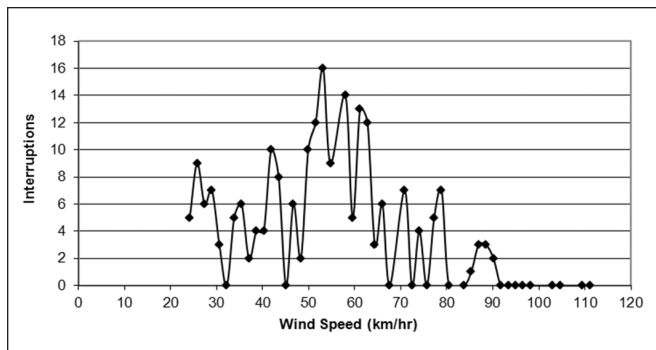
Figure 2. Scatter diagram for transmission interruptions (1998–2007) based on wind speed.

Figure 2 is the result of graphing the number of tree-caused transmission interruptions by wind speed. While the pattern produced is somewhat rough, being based on only 209 records, an approximately normal distribution centered at about 55 km/hr is suggested. There is a note of caution necessary. When utilities experience widespread or what they term major storm damage, the recording of outage causes may be sacrificed in the interest of expediting service restoration. The effects can be seen in the data. Figure 2 shows service interruptions were very low at wind speeds above 90 km/hr. This does not seem logical and is likely attributable to the combination of the incidence of days with winds in excess of 90 km/hr being low and the damage at such wind speeds being so great that the utility dropped the reporting of outages. This is perfectly illustrated by the fact that even though more than 40% of the PSE transmission system was out of service at points through a major storm in December 2006 (pers. comm. PSE), there is only one tree-related transmission record attributed to the storm. Consequently, it may be said that the ten-year outage frequency data represents normal operating conditions for PSE.

The Weibull distribution is a function of a scale parameter α , and a shape parameter β . It is able to assume various shapes to fit varying data sets (Brown 2009a). The α and β parameters can be established by trial and error, fitting the curve (Figure 3) to the data (Figure 2). Once the α and β values for the Weibull distribution were determined, the Weibull distribution was adjusted first (Weibull 1, Figure 4) by minimizing the χ^2 error, and secondly (Weibull 2, Figure 4) by application of a constant to reflect the upper limits of outage frequency. While it appears that the pattern of outage events (Figure 4) can be represented by a normal distribution, this was not statistically verified. The sample size was too small to meet the minimum bin frequency requirement for a Pearson's χ^2 goodness of fit test. Future work, with substantially larger outage incident data sets may serve to validate or reject this assertion. It will require inclusion of distribution system data, which in PSE's case would add more than 33,500 outage incidents to the 265 transmission outages.

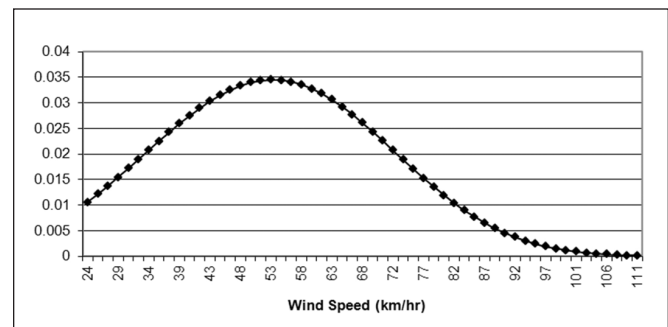
Figure 3. Weibull distribution for transmission outages (1998–2007).

the data (Brown 2009a). The Weibull distribution (Figure 3) represents probability, and the area under the curve equals 1.

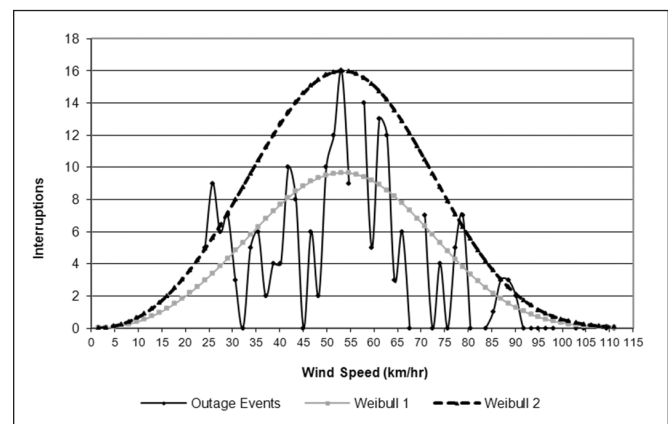
Figure 4. Modeling transmission interruptions based on wind speed (1998–2007).

While modeling transmission tree-related outages via a Weibull distribution could not be statistically verified, the graphics produced in the process are revealing. Figure 4 shows that over the ten-year period most reported tree-related outages occur during winds ranging from 30 to 80 km/hr (estimated from Figure 4).

for PSE could be said to cover wind speeds from 36 to 71 km/hr ($\bar{x} \pm \sigma$) (Figure 4). This may apply to other utilities also at winds

Total transmission system of danger tree exposure was found through trigonometry to be 4,276,395 trees. By dividing the upper limit Weibull modeled outage events (Weibull 2, Figure 4) by the system tree exposure, a ten-year failure rate for each wind speed was calculated. In a similar manner, dividing the Hoerl's regression values by the total tree exposure provides the means of calculating the expected tree-related outages for a particular wind event. In both cases, the failure rates are based on environmental conditions from 1998 through 2007. Assuming all else being equal, changes in system tree exposure will result in new outage expectations, which can be calculated by multiplying the tree exposure by the failure rate.

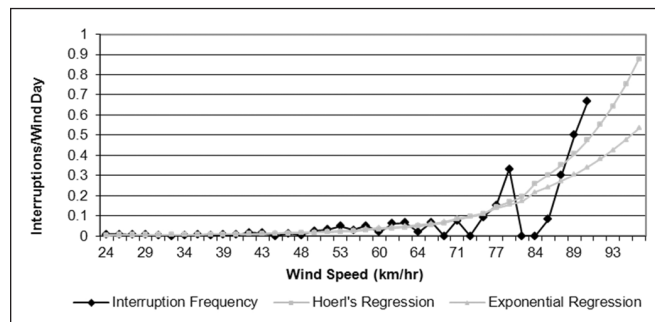
Figure 5. Interruption frequency.

Figures 2 through 4 present data based on a ten-year experience. However, it is also important to know the distribution of outages in response to a single wind event of a particular intensity. To make this determination, an interruption frequency was calculated by dividing the number of reported tree-caused outage events that occurred at a wind speed over the ten-year period by the number of days that wind speed was experienced over the ten-year period. The interruption frequency presented in Figure 5 shows interruptions to be exponential to wind speed. The correlation between wind speed and interruption frequency was tested. This yielded a Pearson Product Moment correlation coefficient of 0.7257 with $P(r = 0)$ of 0.0000. Regression, to explain outage frequency by wind speed, was performed. The exponential regression form provided an r^2 value of 0.8426 with $P = 0.0000$. However, the Hoerl's regression form serves to minimize residuals and has a better fit (Figure 5). The Hoerl's regression has an r^2 of 0.8617 with $P = 0.0000$. The Hoerl's regression produces the algorithm

$$[1] \quad IF = 0.8716053773 * WS^{-3.0114265384} * e^{(0.2056078327 * WS)}$$

where IF is interruption frequency and WS is wind speed.

Utility systems are built to withstand specific levels of wind and ice loading (Wadhwa 2006). This work has made explicit that tree-related outages are exponential to increasing wind loading (Figure 5; Figure 6). Both the system design and the interaction between wind and trees demand a certain staffing level to provide an acceptable level of service. The design and the staffing level are a response to what would be considered a normal system performance expectation (Wadhwa 2006). For PSE, normal conditions may be said to range over wind speeds of up to 71 km/hr ($\bar{x} + \sigma$). It may be expected that PSE is staffed to meet the system performance under these conditions, comprising 98% of the days (Figure 1). Over the ten-year test period, winds in excess of 83 km/hr ($\bar{x} + 2\sigma$) occurred only 0.26% of the days (Figure 1). Figure 7 shows that in the PSE service territory, winds of 97 km/hr are expected to cause tree-related outages an order of magnitude greater than at 71 km/hr and 121 km/hr winds will cause tree-related outages two orders of magnitude greater. If the utility is staffed to expediently remedy outages occurring at 71 km/hr, it will be severely challenged to contain the duration of outages when winds are 97 km/hr and outage incidents increase tenfold. The one hundred fold increase in outages at 121 km/hr winds may be expected to overwhelm the utility.

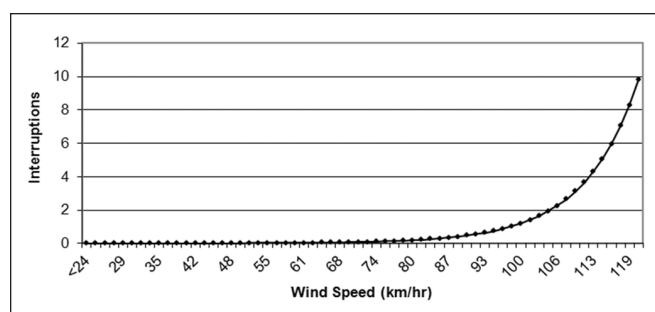
Figure 6. Transmission interruptions per wind incident.

The regression algorithm permits modeling of outages beyond the wind speeds for which data is available. In Figure 6, interruptions for wind speeds up to 121 km/hr are modeled. At 121 km/hr interruptions are approaching an asymptote. This projection fits with observations made in the aftermath of Hurricane Hugo, where it was observed that tree damage increased rapidly with wind gust speeds in excess of 60 km/hr but did not worsen beyond 130 km/hr (Francis and Gillespie 1993).

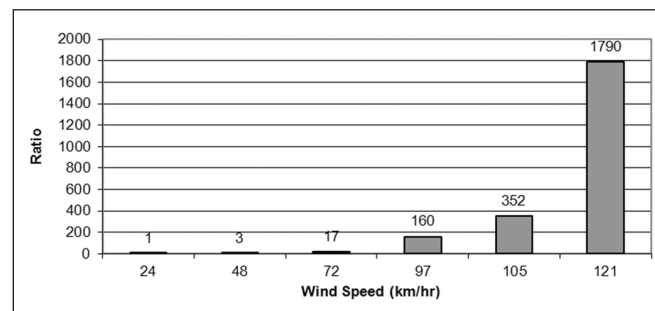
Figure 7. Tree failure ratio.

The ratio of expected interruptions was determined for 24 km/hr, 48 km/hr, 72 km/hr, 97 km/hr, 105 km/hr, and 121 km/hr (Figure 7). The expected outage frequency at 24 km/hr winds was used as the denominator to calculate the ratio of expected interruptions for the range of wind speeds. Normal operating conditions

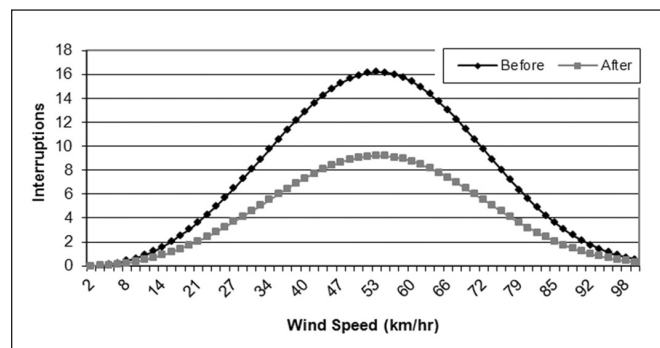
Figure 8. Ten-year outage expectations before and after intervention.

by increasing clear width at all locations where the current tree risk exceeds that of the voltage class mean was examined. The mitigation, if implemented, would reduce the transmission system tree exposure to 3,905,052, or by 8.7%. When the impact of this reduction in tree exposure is graphed over the ten-year wind experience, it produces Figure 8. Figure 8 shows the response to the mitigation to be a 43% reduction in tree-related outages.

This work has demonstrated that tree-related electric service interruptions arising from wind loading can be modeled. While these outage predictions are based on the assumptions of environmental conditions similar to those associated with the historical data, such predictions are useful in comparing various outage mitigation strategies. Furthermore, this work has established that the electric system can be hardened against storm damage caused by tree failures. The system cannot be hardened to withstand wind loading to a particular level. Rather, as mitigation involves the reduction in system tree exposure, there is a uniform percentage reduction in tree-related outages across all wind speeds (Figure 8; Figure 9). It can be concluded that reducing electric system tree exposure will reduce tree-related outages during normal operating conditions (Figure 8) and during major storms (Figure 9).

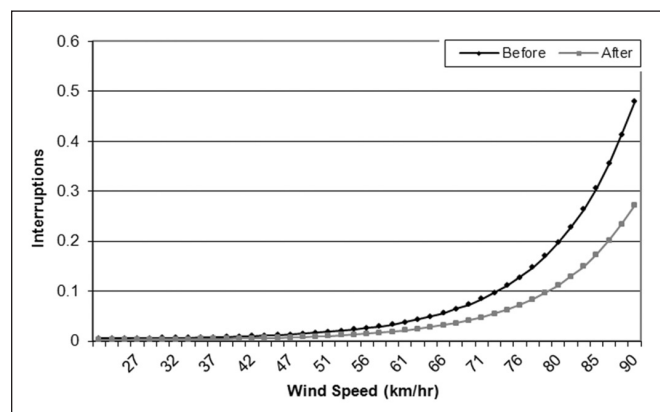
Figure 9. Outages per wind intensity event before and after intervention.

The impact of the same proposed mitigation scenario was also examined for single wind events (Figure 9). It too shows a 43% reduction in tree-related interruptions due to the reduction in system tree exposure.
