Tree-related Electric Outages Due To Wind Loading

Abstract. In the aftermath of a wind storm that interrupted service on more than 40% of Puget Sound Energy's transmission system, the regulator ordered an investigation to evaluate options for hardening the electric system. The initial phase of the study quantified the extent of tree exposure along the transmission system and examined the correlation between various field measurable variables and tree-caused outage frequency. This phase of the work correlated 10 years of wind data with 10 years of outage data. Tree failure rates were calculated and used to model tree-caused outage expectations based on wind speed. Models were developed to assess the outage impact of interventions that reduce the transmission system exposure to trees.

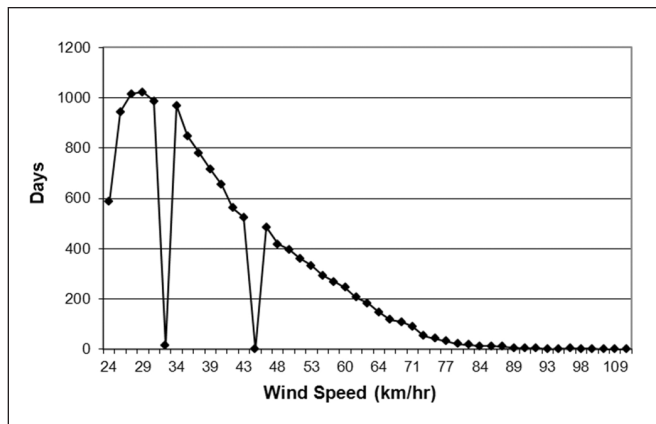
Figure 1. PSE service territory ten-year wind frequency (1998–2007). Note: Y-axis is number of days when winds of a specific speed were experienced at one or more of the nine airfields.

Graphics to represent the frequency of wind events and outages associated with wind speed were developed. The troughs in the data at 32 and 45 km/hr (Figure 1), and the saw tooth pattern or variability (Figure 2), made it apparent that a modeling approach was needed to smooth out the data. Exponential regression was used to develop algorithms to predict tree-related outage events.

It was found that over the ten-year period, 18% of the days had sustained wind speeds of less than 24 km/hr. Fifty-six of the 265 tree-caused transmission interruptions occurred under these conditions. Without detailed data on winds below 24 km/hr, the shape

of the frequency distribution is not explicit, but there is enough data to know that it is a positively skewed distribution (Figure 1).

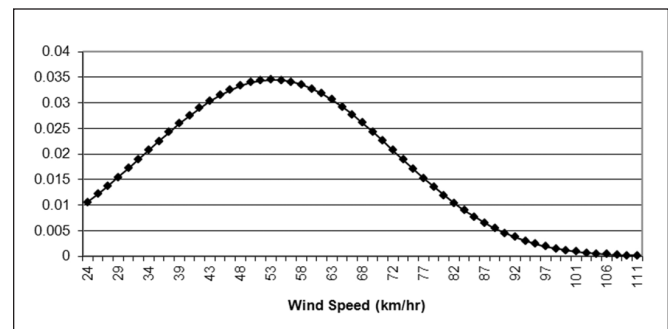
Figure 3. Weibull distribution for transmission outages (1998–2007).

the data (Brown 2009a). The Weibull distribution (Figure 3) represents probability, and the area under the curve equals 1.

The Weibull distribution is a function of a scale parameter α , and a shape parameter β . It is able to assume various shapes to fit varying data sets (Brown 2009a). The α and β parameters can be established by trial and error, fitting the curve (Figure 3) to the data (Figure 2). Once the α and β values for the Weibull distribution were determined, the Weibull distribution was adjusted first (Weibull 1, Figure 4) by minimizing the χ^2 error, and secondly (Weibull 2, Figure 4) by application of a constant to reflect the upper limits of outage frequency. While it appears that the pattern of outage events (Figure 4) can be represented by a normal distribution, this was not statistically verified. The sample size was too small to meet the minimum bin frequency requirement for a Pearson's χ^2 goodness of fit test. Future work, with substantially larger outage incident data sets may serve to validate or reject this assertion. It will require inclusion of distribution system data, which in PSE's case would add more than 33,500 outage incidents to the 265 transmission outages.

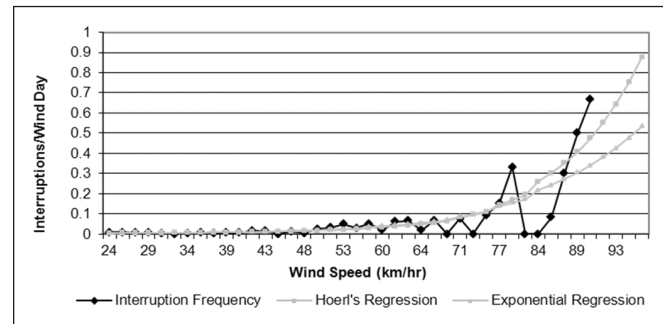
Figure 5. Interruption frequency.

Figures 2 through 4 present data based on a ten-year experience. However, it is also important to know the distribution of outages in response to a single wind event of a particular intensity. To make this determination, an interruption frequency was calculated by dividing the number of reported tree-caused outage events that occurred at a wind speed over the ten-year period by the number of days that wind speed was experienced over the ten-year period. The interruption frequency presented in Figure 5 shows interruptions to be exponential to wind speed. The correlation between wind speed and interruption frequency was tested. This yielded a Pearson Product Moment correlation coefficient of 0.7257 with $P(r = 0)$ of 0.0000. Regression, to explain outage frequency by wind speed, was performed. The exponential regression form provided an r^2 value of 0.8426 with $P = 0.0000$. However, the Hoerl's regression form serves to minimize residuals and has a better fit (Figure 5). The Hoerl's regression has an r^2 of 0.8617 with $P = 0.0000$. The Hoerl's regression produces the algorithm

$$[1] \quad IF = 0.8716053773 * WS^{-3.0114265384} * e^{(0.2056078327 * WS)}$$

Utility systems are built to withstand specific levels of wind and ice loading (Wadhwa 2006). This work has made explicit that tree-related outages are exponential to increasing wind loading (Figure 5; Figure 6). Both the system design and the interaction between wind and trees demand a certain staffing level to provide an acceptable level of service. The design and the staffing level are a response to what would be considered a normal system performance expectation (Wadhwa 2006). For PSE, normal conditions may be said to range over wind speeds of up to 71 km/hr ($\bar{x} + \sigma$). It may be expected that PSE is staffed to meet the system performance under these conditions, comprising 98% of the days (Figure 1). Over the ten-year test period, winds in excess of 83 km/hr ($\bar{x} + 2\sigma$) occurred only 0.26% of the days (Figure 1). Figure 7 shows that in the PSE service territory, winds of 97 km/hr are expected to cause tree-related outages an order of magnitude greater than at 71 km/hr and 121 km/hr winds will cause tree-related outages two orders of magnitude greater. If the utility is staffed to expediently remedy outages occurring at 71 km/hr, it will be severely challenged to contain the duration of outages when winds are 97 km/hr and outage incidents increase tenfold. The one hundred fold increase in outages at 121 km/hr winds may be expected to overwhelm the utility.

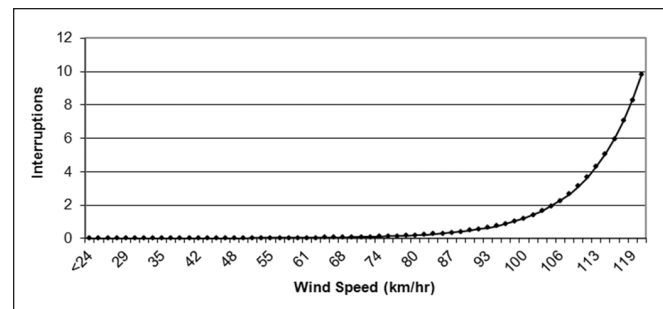
Figure 6. Transmission interruptions per wind incident.

The regression algorithm permits modeling of outages beyond the wind speeds for which data is available. In Figure 6, interruptions for wind speeds up to 121 km/hr are modeled. At 121 km/hr interruptions are approaching an asymptote. This projection fits with observations made in the aftermath of Hurricane Hugo, where it was observed that tree damage increased rapidly with wind gust speeds in excess of 60 km/hr but did not worsen beyond 130 km/hr (Francis and Gillespie 1993).

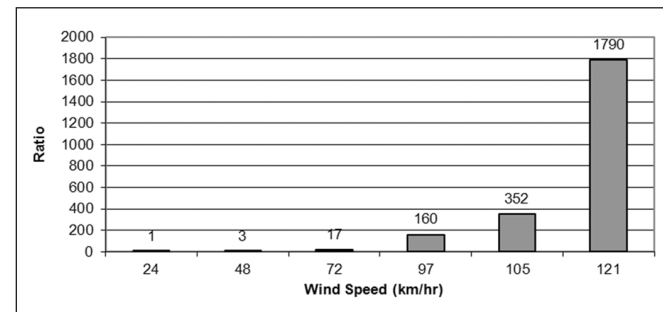
Figure 7. Tree failure ratio.

The ratio of expected interruptions was determined for 24 km/hr, 48 km/hr, 72 km/hr, 97 km/hr, 105 km/hr, and 121 km/hr (Figure 7). The expected outage frequency at 24 km/hr winds was used as the denominator to calculate the ratio of expected interruptions for the range of wind speeds. Normal operating conditions

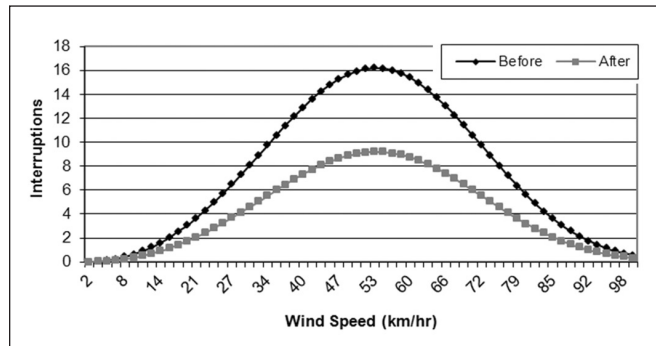
Figure 8. Ten-year outage expectations before and after intervention.

by increasing clear width at all locations where the current tree risk exceeds that of the voltage class mean was examined. The mitigation, if implemented, would reduce the transmission system tree exposure to 3,905,052, or by 8.7%. When the impact of this reduction in tree exposure is graphed over the ten-year wind experience, it produces Figure 8. Figure 8 shows the response to the mitigation to be a 43% reduction in tree-related outages.

This work has demonstrated that tree-related electric service interruptions arising from wind loading can be modeled. While these outage predictions are based on the assumptions of environmental conditions similar to those associated with the historical data, such predictions are useful in comparing various outage mitigation strategies. Furthermore, this work has established that the electric system can be hardened against storm damage caused by tree failures. The system cannot be hardened to withstand wind loading to a particular level. Rather, as mitigation involves the reduction in system tree exposure, there is a uniform percentage reduction in tree-related outages across all wind speeds (Figure 8; Figure 9). It can be concluded that reducing electric system tree exposure will reduce tree-related outages during normal operating conditions (Figure 8) and during major storms (Figure 9).

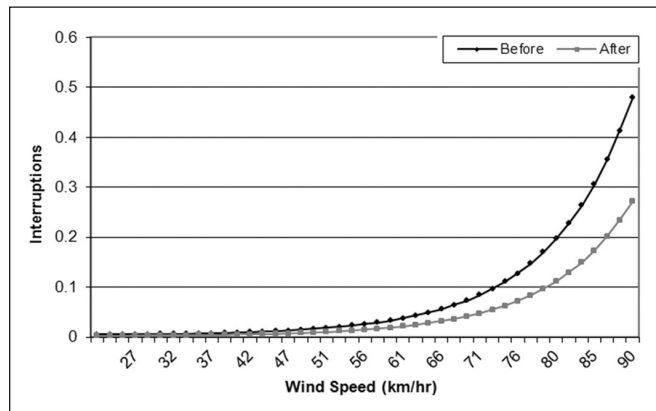
Figure 9. Outages per wind intensity event before and after intervention.

The impact of the same proposed mitigation scenario was also examined for single wind events (Figure 9). It too shows a 43% reduction in tree-related interruptions due to the reduction in system tree exposure.
