Tree-related Electric Outages Due To Wind Loading

Abstract. In the aftermath of a wind storm that interrupted service on more than 40% of Puget Sound Energy's transmission system, the regulator ordered an investigation to evaluate options for hardening the electric system. The initial phase of the study quantified the extent of tree exposure along the transmission system and examined the correlation between various field measurable variables and tree-caused outage frequency. This phase of the work correlated 10 years of wind data with 10 years of outage data. Tree failure rates were calculated and used to model tree-caused outage expectations based on wind speed. Models were developed to assess the outage impact of interventions that reduce the transmission system exposure to trees.

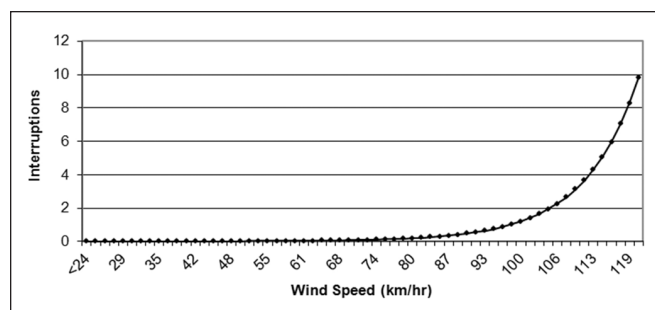
Figure 6. Transmission interruptions per wind incident.

The regression algorithm permits modeling of outages beyond the wind speeds for which data is available. In Figure 6, interruptions for wind speeds up to 121 km/hr are modeled. At 121 km/hr interruptions are approaching an asymptote. This projection fits with observations made in the aftermath of Hurricane Hugo, where it was observed that tree damage increased rapidly with wind gust speeds in excess of 60 km/hr but did not worsen beyond 130 km/hr (Francis and Gillespie 1993).

Utility systems are built to withstand specific levels of wind and ice loading (Wadhwa 2006). This work has made explicit that tree-related outages are exponential to increasing wind loading (Figure 5; Figure 6). Both the system design and the interaction between wind and trees demand a certain staffing level to provide an acceptable level of service. The design and the staffing level are a response to what would be considered a normal system performance expectation (Wadhwa 2006). For PSE, normal conditions may be said to range over wind speeds of up to 71 km/hr ($\bar{x} + \sigma$). It may be expected that PSE is staffed to meet the system performance under these conditions, comprising 98% of the days (Figure 1). Over the ten-year test period, winds in excess of 83 km/hr ($\bar{x} + 2\sigma$) occurred only 0.26% of the days (Figure 1). Figure 7 shows that in the PSE service territory, winds of 97 km/hr are expected to cause tree-related outages an order of magnitude greater than at 71 km/hr and 121 km/hr winds will cause tree-related outages two orders of magnitude greater. If the utility is staffed to expediently remedy outages occurring at 71 km/hr, it will be severely challenged to contain the duration of outages when winds are 97 km/hr and outage incidents increase tenfold. The one hundred fold increase in outages at 121 km/hr winds may be expected to overwhelm the utility.

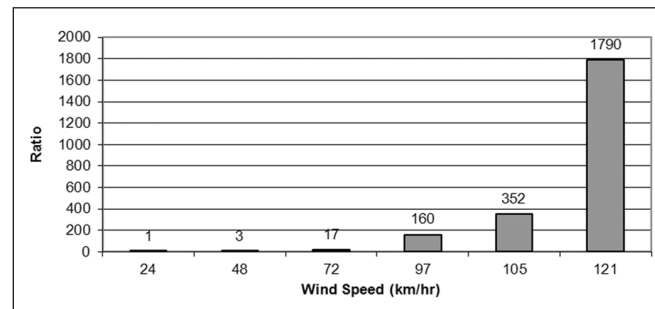
Figure 7. Tree failure ratio.

The ratio of expected interruptions was determined for 24 km/hr, 48 km/hr, 72 km/hr, 97 km/hr, 105 km/hr, and 121 km/hr (Figure 7). The expected outage frequency at 24 km/hr winds was used as the denominator to calculate the ratio of expected interruptions for the range of wind speeds. Normal operating conditions
