Tree-related Electric Outages Due To Wind Loading

Siegfried Guggenmoos

Abstract. In the aftermath of a wind storm that interrupted service on more than 40% of Puget Sound Energy's transmission system, the regulator ordered an investigation to evaluate options for hardening the electric system. The initial phase of the study quantified the extent of tree exposure along the transmission system and examined the correlation between various field measurable variables and tree-caused outage frequency. This phase of the work correlated 10 years of wind data with 10 years of outage data. Tree failure rates were calculated and used to model tree-caused outage expectations based on wind speed. Models were developed to assess the outage impact of interventions that reduce the transmission system exposure to trees.

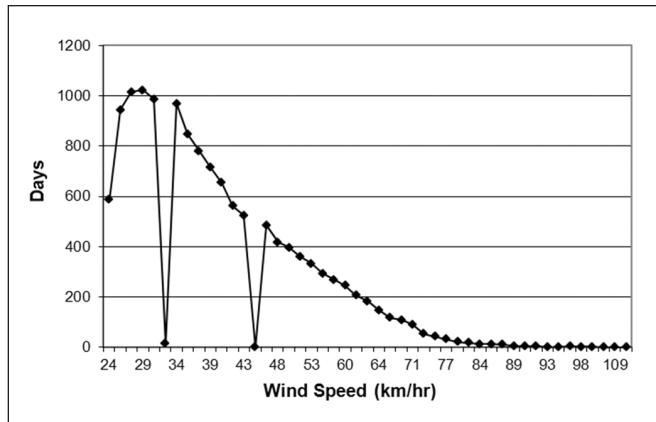
Figure 1. PSE service territory ten-year wind frequency (1998–2007). Note: Y-axis is number of days when winds of a specific speed were experienced at one or more of the nine airfields.

Graphics to represent the frequency of wind events and outages associated with wind speed were developed. The troughs in the data at 32 and 45 km/hr (Figure 1), and the saw tooth pattern or variability (Figure 2), made it apparent that a modeling approach was needed to smooth out the data. Exponential regression was used to develop algorithms to predict tree-related outage events.

It was found that over the ten-year period, 18% of the days had sustained wind speeds of less than 24 km/hr. Fifty-six of the 265 tree-caused transmission interruptions occurred under these conditions. Without detailed data on winds below 24 km/hr, the shape

of the frequency distribution is not explicit, but there is enough data to know that it is a positively skewed distribution (Figure 1).

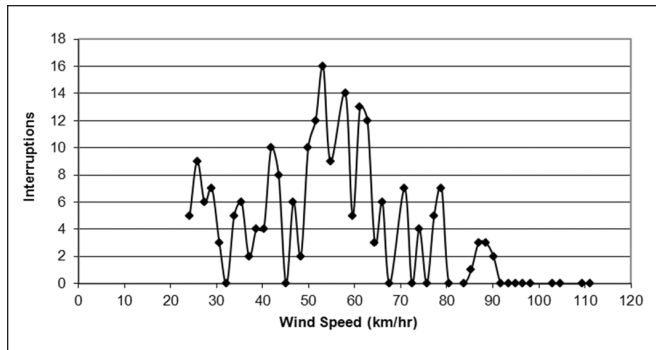
Figure 2. Scatter diagram for transmission interruptions (1998–2007) based on wind speed.

Figure 2 is the result of graphing the number of tree-caused transmission interruptions by wind speed. While the pattern produced is somewhat rough, being based on only 209 records, an approximately normal distribution centered at about 55 km/hr is suggested. There is a note of caution necessary. When utilities experience widespread or what they term major storm damage, the recording of outage causes may be sacrificed in the interest of expediting service restoration. The effects can be seen in the data. Figure 2 shows service interruptions were very low at wind speeds above 90 km/hr. This does not seem logical and is likely attributable to the combination of the incidence of days with winds in excess of 90 km/hr being low and the damage at such wind speeds being so great that the utility dropped the reporting of outages. This is perfectly illustrated by the fact that even though more than 40% of the PSE transmission system was out of service at points through a major storm in December 2006 (pers. comm. PSE), there is only one tree-related transmission record attributed to the storm. Consequently, it may be said that the ten-year outage frequency data represents normal operating conditions for PSE.

The Weibull distribution is a function of a scale parameter α , and a shape parameter β . It is able to assume various shapes to fit varying data sets (Brown 2009a). The α and β parameters can be established by trial and error, fitting the curve (Figure 3) to the data (Figure 2). Once the α and β values for the Weibull distribution were determined, the Weibull distribution was adjusted first (Weibull 1, Figure 4) by minimizing the χ^2 error, and secondly (Weibull 2, Figure 4) by application of a constant to reflect the upper limits of outage frequency. While it appears that the pattern of outage events (Figure 4) can be represented by a normal distribution, this was not statistically verified. The sample size was too small to meet the minimum bin frequency requirement for a Pearson's χ^2 goodness of fit test. Future work, with substantially larger outage incident data sets may serve to validate or reject this assertion. It will require inclusion of distribution system data, which in PSE's case would add more than 33,500 outage incidents to the 265 transmission outages.

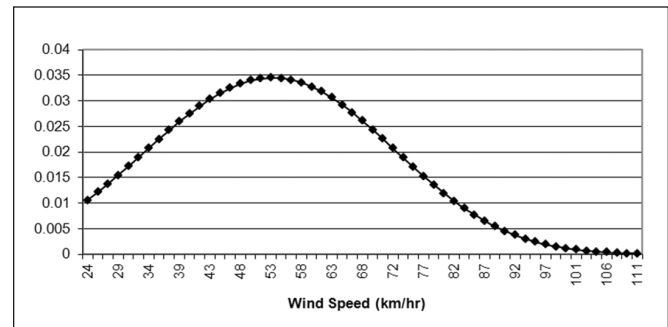
Figure 3. Weibull distribution for transmission outages (1998–2007).

the data (Brown 2009a). The Weibull distribution (Figure 3) represents probability, and the area under the curve equals 1.

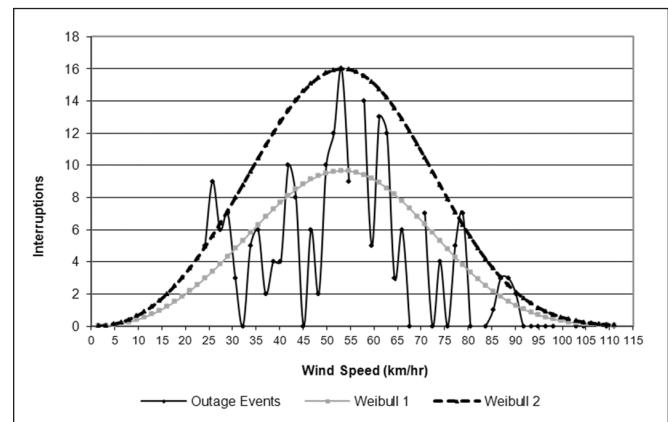
Figure 4. Modeling transmission interruptions based on wind speed (1998–2007).

While modeling transmission tree-related outages via a Weibull distribution could not be statistically verified, the graphics produced in the process are revealing. Figure 4 shows that over the ten-year period most reported tree-related outages occur during winds ranging from 30 to 80 km/hr (estimated from Figure 4).

for PSE could be said to cover wind speeds from 36 to 71 km/hr ($\bar{x} \pm \sigma$) (Figure 4). This may apply to other utilities also at winds

Total transmission system of danger tree exposure was found through trigonometry to be 4,276,395 trees. By dividing the upper limit Weibull modeled outage events (Weibull 2, Figure 4) by the system tree exposure, a ten-year failure rate for each wind speed was calculated. In a similar manner, dividing the Hoerl's regression values by the total tree exposure provides the means of calculating the expected tree-related outages for a particular wind event. In both cases, the failure rates are based on environmental conditions from 1998 through 2007. Assuming all else being equal, changes in system tree exposure will result in new outage expectations, which can be calculated by multiplying the tree exposure by the failure rate.

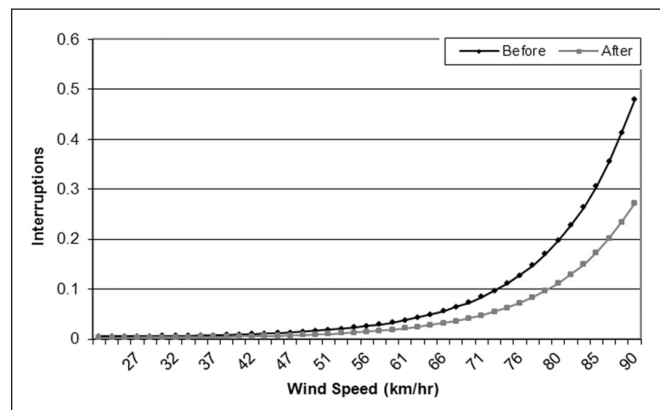
Figure 9. Outages per wind intensity event before and after intervention.

The impact of the same proposed mitigation scenario was also examined for single wind events (Figure 9). It too shows a 43% reduction in tree-related interruptions due to the reduction in system tree exposure.

This work has demonstrated that tree-related electric service interruptions arising from wind loading can be modeled. While these outage predictions are based on the assumptions of environmental conditions similar to those associated with the historical data, such predictions are useful in comparing various outage mitigation strategies. Furthermore, this work has established that the electric system can be hardened against storm damage caused by tree failures. The system cannot be hardened to withstand wind loading to a particular level. Rather, as mitigation involves the reduction in system tree exposure, there is a uniform percentage reduction in tree-related outages across all wind speeds (Figure 8; Figure 9). It can be concluded that reducing electric system tree exposure will reduce tree-related outages during normal operating conditions (Figure 8) and during major storms (Figure 9).
