Tree-related Electric Outages Due To Wind Loading

Siegfried Guggenmoos

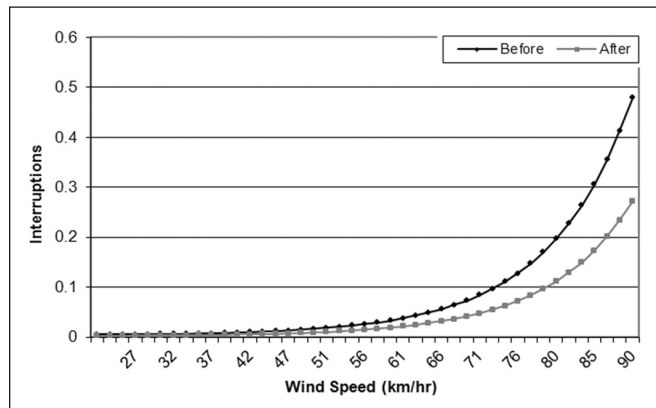
Figure 9. Outages per wind intensity event before and after intervention.

The impact of the same proposed mitigation scenario was also examined for single wind events (Figure 9). It too shows a 43% reduction in tree-related interruptions due to the reduction in system tree exposure.

This work has demonstrated that tree-related electric service interruptions arising from wind loading can be modeled. While these outage predictions are based on the assumptions of environmental conditions similar to those associated with the historical data, such predictions are useful in comparing various outage mitigation strategies. Furthermore, this work has established that the electric system can be hardened against storm damage caused by tree failures. The system cannot be hardened to withstand wind loading to a particular level. Rather, as mitigation involves the reduction in system tree exposure, there is a uniform percentage reduction in tree-related outages across all wind speeds (Figure 8; Figure 9). It can be concluded that reducing electric system tree exposure will reduce tree-related outages during normal operating conditions (Figure 8) and during major storms (Figure 9).
