DEFLECTING ROOTS NEAR SIDEWALKS

Edward F. Gilman

Abstract. Concrete sidewalks 10 cm (4 in) thick measuring 1.2 m (4.5 ft) wide by 5 m (16.5 ft) long were installed in spring 1996 with and without barriers designed to deflect roots. Forty-eight *Platanus occidentalis* from #15 containers were planted 0.75 m (30 in) from sidewalks and irrigated regularly to encourage rapid growth. Identical studies were installed on one well-drained and one poorly drained site located about 18 km (11.2 miles) apart. Barriers included 30 cm (12 in) deep DeepRoot, Biobarrier®, polyethylene (6 mil), a clean gravel layer (15 cm [6 in] deep; 2 to 3 cm [0.8 to 1.2 in] diameter) under the walk, and a control without a barrier. Roots were excavated 8 years after planting. No roots grew in the gravel in the well-drained site, resulting in a significantly deeper root system (19 cm [7.6 in]) under the walks than all other treatments (11 cm [4.4 in]). Vertical root barriers did not increase root depth compared to the control on the well-drained soil. Gravel under the walk and Biobarrier were most effective on poorly drained soil. DeepRoot was the least effective vertical barrier on the poorly drained site; Bio

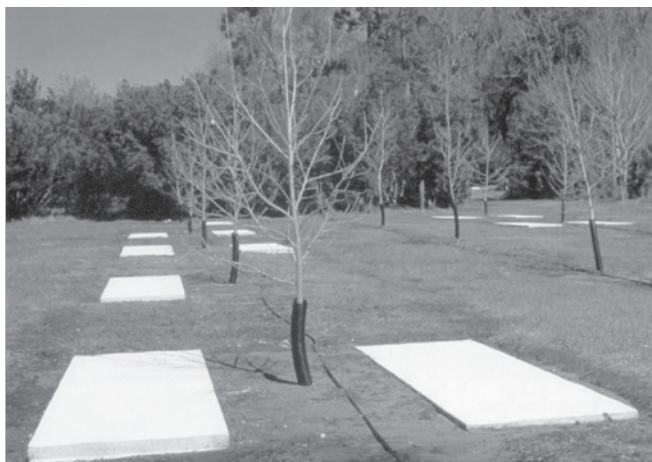
Figure 1. One tree was planted between sidewalk sections with various vertical root barriers on the tree side of the walk, or gravel under the walk, or a control without a barrier.

Six treatments were installed at each site, including (1) no sidewalk and no root barrier, (2) sidewalk and no root barrier, (3) Biobarrier® 30 cm (12 in) deep installed vertically next to sidewalk, (4) DeepRoot 30 cm (12 in) deep installed vertically next to sidewalk, (5) polyethylene (6 mil) plastic installed vertically next to sidewalk, and (6) a clean gravel (2.5 cm [1 in] diameter without fines or soil) layer 15 cm (6 in) deep under the sidewalk. Vertical barriers were installed in an 8 cm (3.2 in) wide trench about 2.5 cm (1 in) from the concrete edge on the side of the walk where the trees were planted. The top of the vertical barriers was about 2.5 cm (1 in) above the soil surface. Gravel was spread after cutting the grade 22 cm (9.2 in) with a front-end loader blade. Concrete was poured directly over gravel; concrete did not penetrate between gravel pieces.
