STREET TREES IN HIGH-DENSITY URBAN HONG KONG

by C. Y. Jim

Abstract. High-density urban Hong Kong has a small population of street trees. A survey of 930 trees in two districts provide information on tree characteristics and for management. Of the 55 species encountered, few are numerically dominant and currently cultivated. The rare species are mainly woodland or garden relics. Species selection is shifting from native/large to introduced/small. Some popular species are not quite suitable for streets; a few rare voluntary species perform well. Most trees are concentrated along a few roads where growth space is available. Plantable space is a major bottleneck. The distribution of trees by growth type, position, and proximal landuse are discussed. Most trees have narrow crowns and are short-statured, suggesting a youthful population and/or a recent trend to plant small species. Two-thirds have arboricultural problems. Lack of tree data and of regular inspections make planning for tree care difficult. Maintenance is grossly inadequate due to lack of skilled workers. The poor tree health and defects are likely to persist.

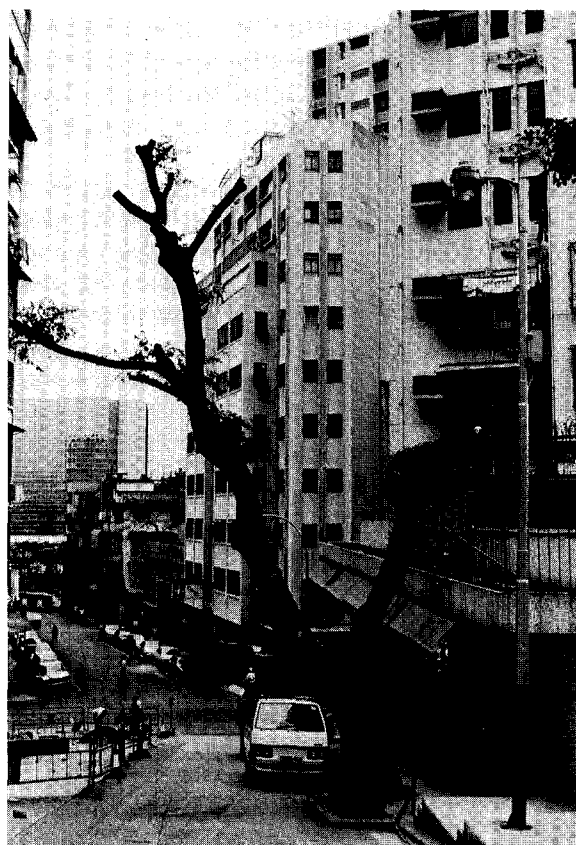
Fig. 1. This *Ficus microcarpa* (Chinese Banyan) had been lopped so excessively that the effort to keep it is rendered meaningless.

searching roots render it suitable for street planting only in ample roadside spaces. Many large specimens were sacrificed as the city expanded. Most of these trees have reached full size, and many show signs of decline. Some survivors are stranded incongruously in narrow streets, abutting adjacent buildings. Excessive pruning or lopping often were carried out to prevent obstruction to traffic or building redevelopment (Fig. 1). These maltreatments, plus senescence, leave few good trees of this species.

Physical restrictions. Above-ground space is very restricted for 7% of the trees. Physical obstacles include buildings (especially with awnings), vehicles, signs and lamp-posts (Fig. 1 and 5). The trees' crowns are incomplete. Wrong species, mis-siting, typhoon damage, construction, and general decline and dieback also cause this. Building or road development often has priority over trees' crowns (Fig. 1 and 5). Selection and siting cannot preclude landuse change.

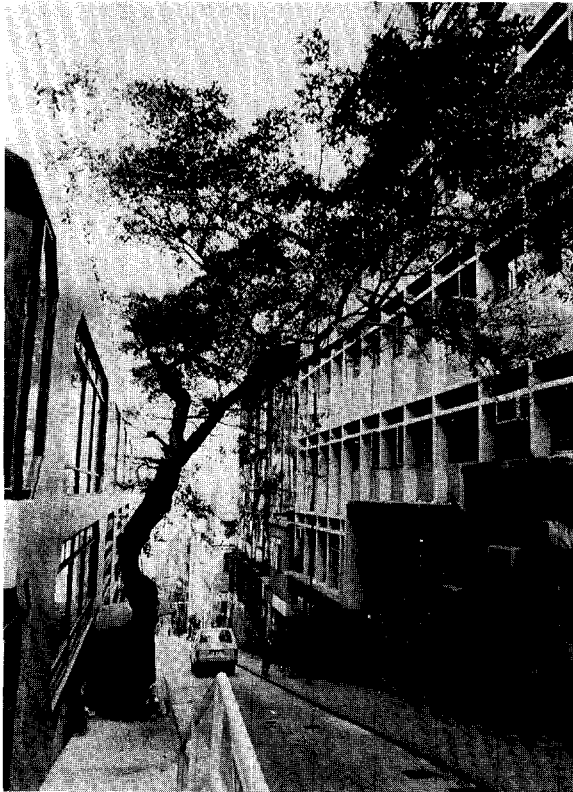
Fig. 5. This *Ficus microcarpa* (Chinese Banyan) has been severely deformed and left trapped on a narrow sidewalk without a tree pit as a result of building redevelopment.

Figure 4 shows the trees' growth positions. Most are on property or curb side of the sidewalk. But some straddle the sidewalk obstructing pedestrians due to road alignments (Fig. 5). About 13% are in the few recently built central dividers.
