# FACTORS AFFECTING ACCUMULATION OF DEICING SALTS IN SOILS AROUND TREES

by R.G. Hootman, P.D. Kelsey, R. Reid, and K. von der Heide-Spravka

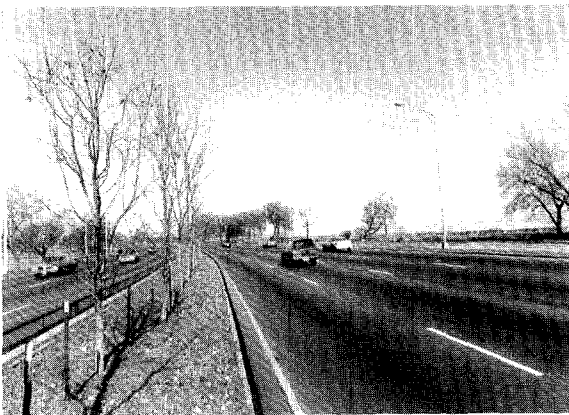
**Figure 1. Narrow median planter along Lake Shore Drive, Chicago, with Lake Michigan in the right background. The planter is raised 0.8 m (2.5 ft) above the roadway. Photo credit: Jim Nachel**

and two sites were within a wide, road-level median. Traffic counts at each site show essentially equal traffic levels (2). The narrow median is 3 m (10 ft) wide and raised 0.8 m (2.5 ft) above the roadway (Figure 1). The wide median is about 30 m (100 ft) across and level with the roadway. One surface soil sample (0-15 cm deep, 0-6 in) was gathered on 28 December 1992 and on 30 March 1993 in the center of each median site.

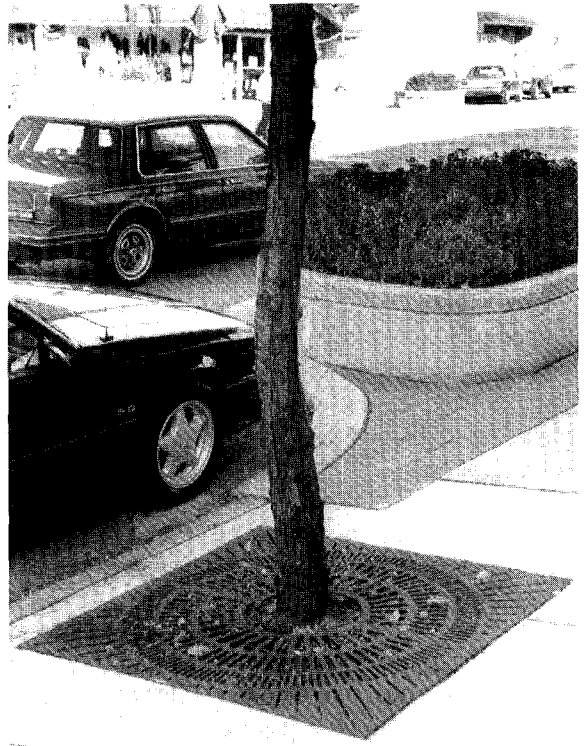
**Figure 2. Grade level and raised planters in Downers Grove. Photo credit: Jim Nachel**

Streets in the Downers Grove CBD are two lanes and speeds are less than 50 km per hour (30 mph) due to the stop-and-go traffic at intersections. A soil sample was taken at each of two grade level planters and each of two raised planters in 1991; only one grade level planter and one raised planter were sampled in 1993 (Figure 2). Samples in Downers Grove were taken at depths of 0-10 cm (0-4 in) and 20-30 cm (8-12 in).
