TREE ROOT DAMAGE TO SIDEWALKS AND CURBS

by J. Alan Wagar and Philip A. Barker

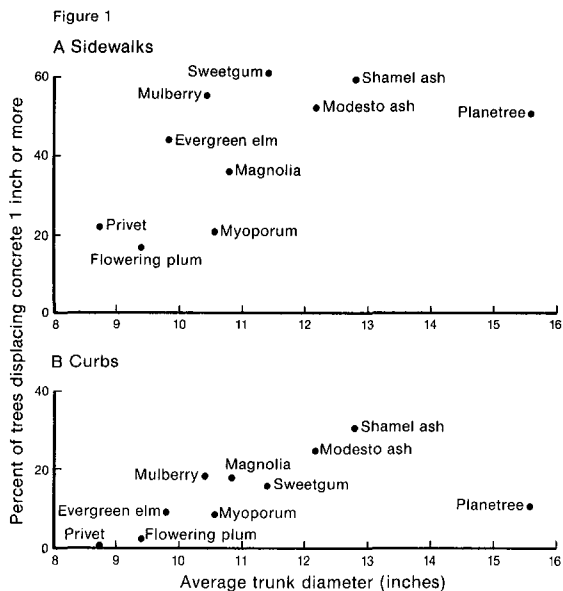
Figure 1. Relation of average diameter of tree species to (A) percentage of trees that damaged sidewalks and (B) percentage of trees that damaged curbs.

As expected, more large trees caused damage than did small trees (Fig. 1). After the effects of size, soil texture, and planting-strip width had been accounted for by regression analysis, the 10 species studied were ranked from most to least damaging as follows: sweetgum, fruitless

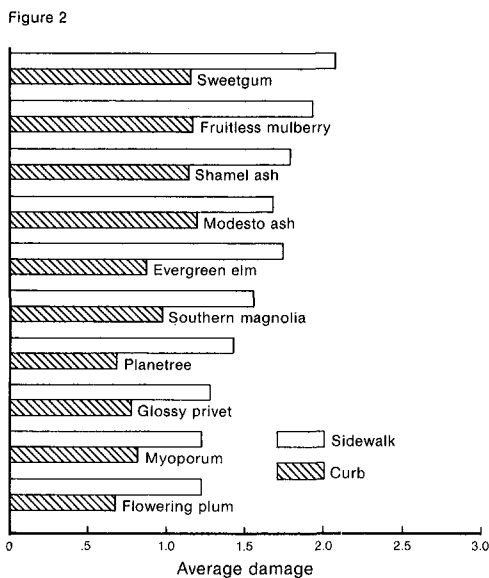
Figure 2. Ranking of tree species by amount of damage to sidewalks and curbs (scale: 0 = no damage to 3 = concrete displaced more than 2 inches.).

mulberry, Shamel ash, Modesto ash, evergreen elm, southern magnolia, planetree, glossy privet, myoporum, and flowering plum (Fig. 2). Although the ranking is approximate, it indicates which species are likely to cause damage substantially above or below average. The average difference between the most and least damaging species on a scale of 0 to 3 was 0.85 for sidewalks and 0.45 for curbs.

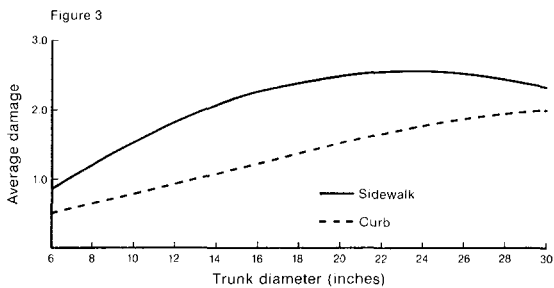
Figure 3. Approximate effect of trunk diameter on damage to sidewalks and curbs as determined by using regression equations to adjust estimated damage for planting strip width, tree species, and soil texture. (Damage scale: 0 = no damage to 3 = concrete displaced more than 2 inches).

We estimated the average effects of tree diameter, planting strip width, and soil texture, using regression analysis to correct for other variables. The severity of damage increased with tree diameter (Fig. 3) and averaged greatest in the narrowest planting strips (Fig. 4). Sidewalk damage averaged somewhat less in the lightest soil class (soil 1) than in the other classes (Fig. 5).

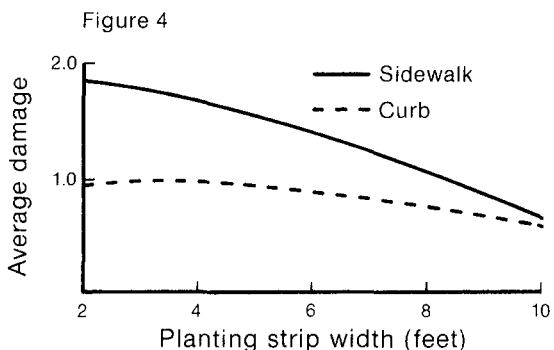
Figure 4. Approximate effect of planting strip width on damage to sidewalks and curbs as determined by using regression equations to adjust estimated damage for trunk diameter, tree species, and soil texture. (Damage scale: 0 = no damage to 3 = concrete displaced more than 2 inches).

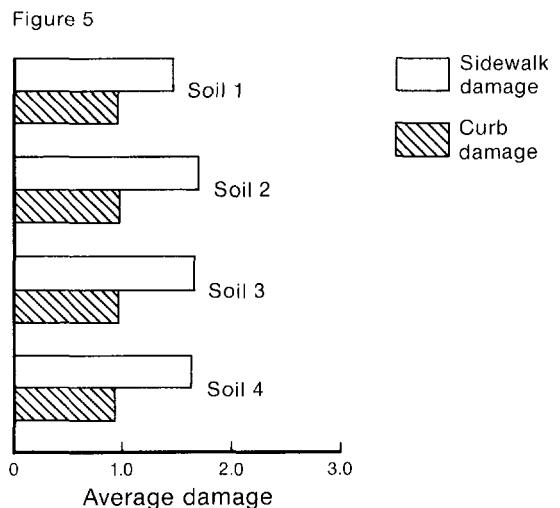
Figure 5. Approximate effect of soil texture on damage to sidewalks and curbs as determined by using regression equations to adjust estimated damage for trunk diameter, planting strip width, and tree species. (Damage scale: 0 = no damage to 3 = concrete displaced more than 2 inches; soil 1 had most sand, soil 4 had most clay).
